**Sub:** Intimation regarding collapse of Tower no. 150 of Jaigad – Karad Transmission line

**Subject: Restoration works of collapsed tower at Location no 150 of 400kV JTPL Jaigad-Karad Line**

A report on restoration of collapsed tower at location 150 of 400kV D/C (Quad) Jaigad-Karad transmission line

By, Jaigad PowerTransco Ltd  
(A Joint venture of JSWEL & MSETCL)

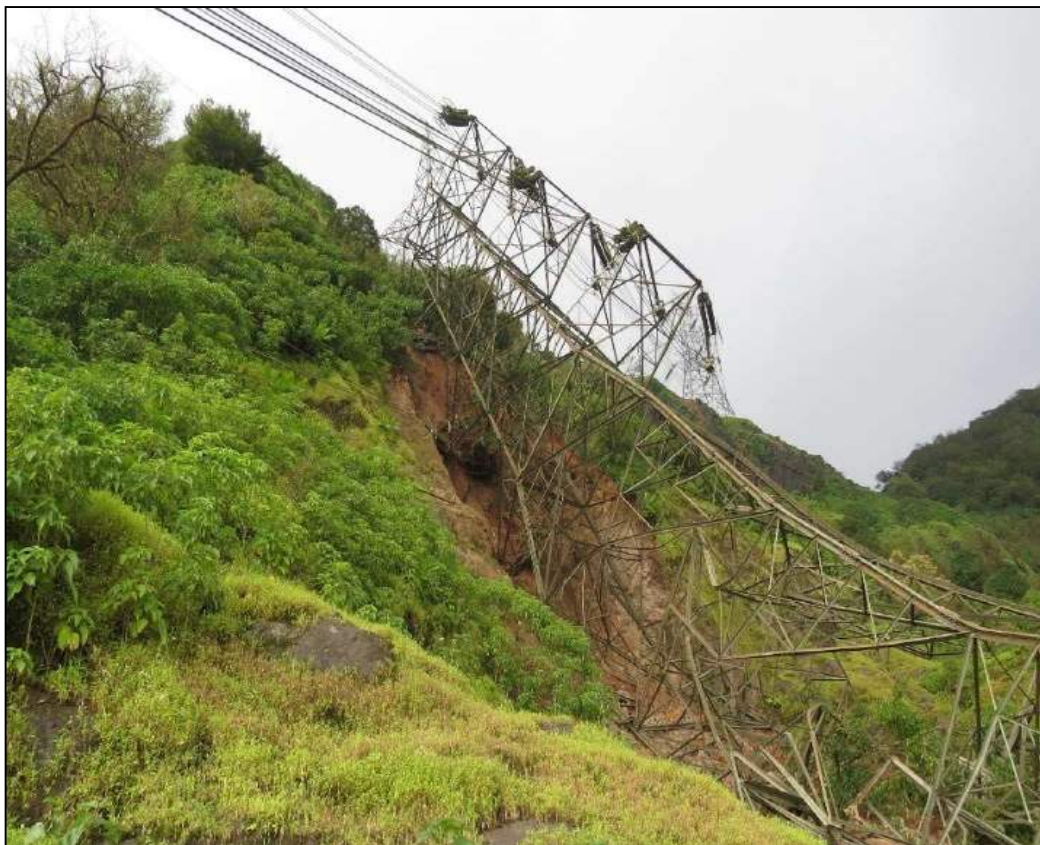
Collapsed tower no 150 (Jaigad-Karad line)

This is to inform you that the Tower no. 150 of the Jaigad – Karad transmission line collapsed on the evening of 27<sup>th</sup> September 2020. The tower was positioned on the hilly region and there was a landslide due to the heavy rains. Heavy boulders came down damaging the lower members of the tower resulting in the collapse.

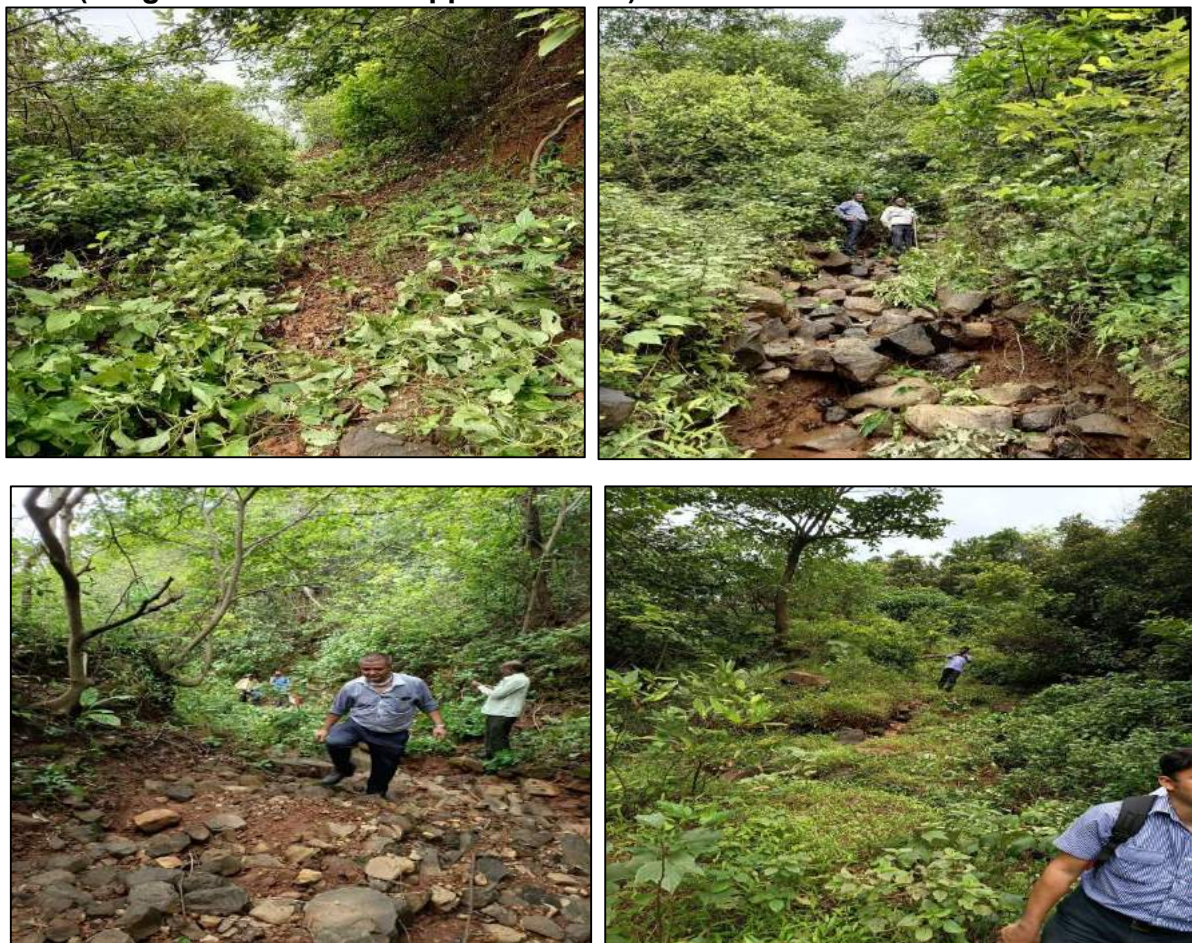
**(Images: Non-existent approach road)**

To commence any kind of tower line maintenance works, an availability of approach road plays a vital role in order to speedy mobility to the Tower & Construction material as well as T&P. In our case, since tower is located on hill top (2000 ft AMSL), approach time to reach at location by walking through forest area takes around 2:30 hours. The road constructed during construction period was almost non-existent as rain-cuts have washed the road at most places. Hence mobilizing men, material & required T&P's at collapsed tower 150 was one of the crucial & tough task of the restoration works.

JPTL has engaged M/s.Kasar construction for making approach road till tower location 150, who has also worked during construction phase of the tower. They have deployed machineries like poclain, JCB, dumper as well as tractor on 02<sup>nd</sup> October 2020 and prepared tractorable road up to location 149.

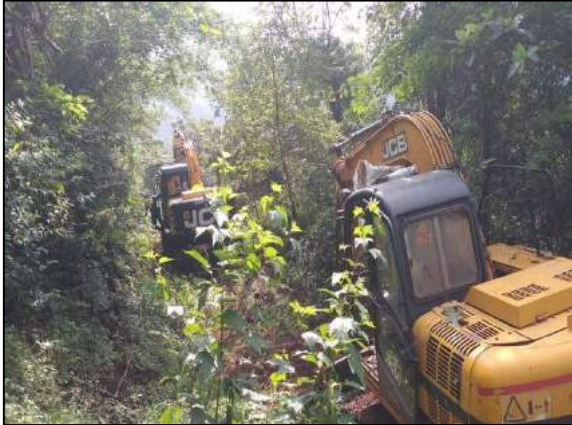
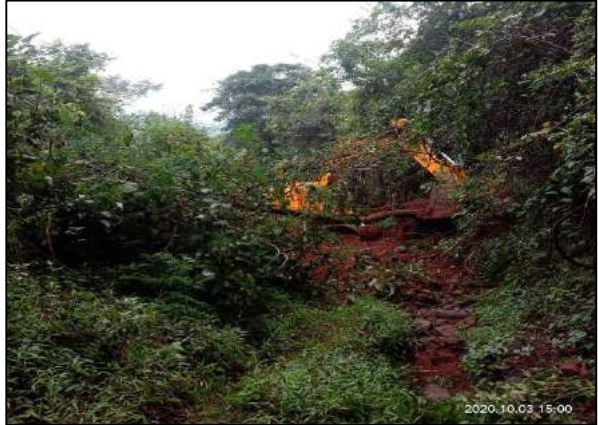
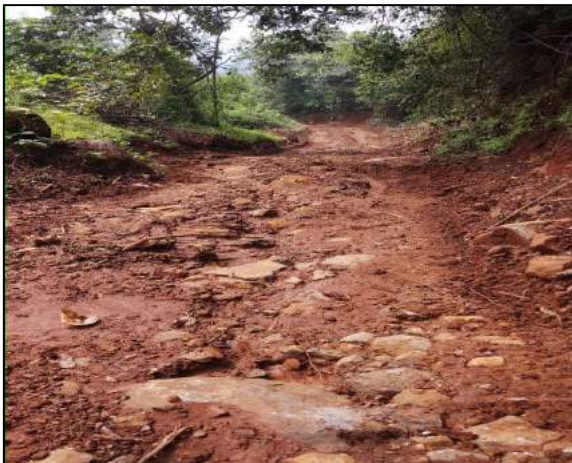
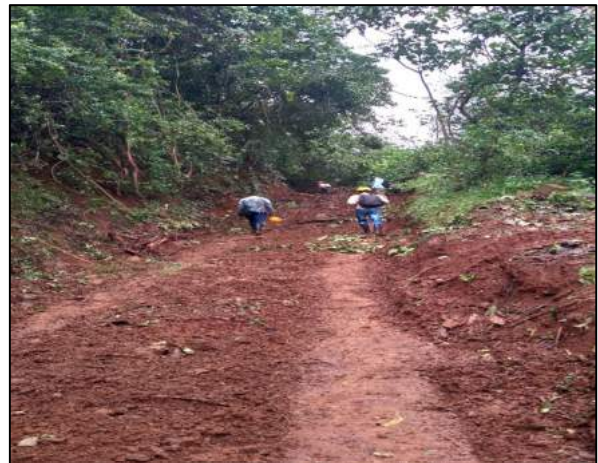
**(Images: Approach road under construction)**

The work was severally affected due to rainfall (extended return monsoon) which started from 08<sup>th</sup> Oct 2020 till 25<sup>th</sup> Oct 2020. As a result, multiple times road repairing need to be undertake in order to commence material shifting.

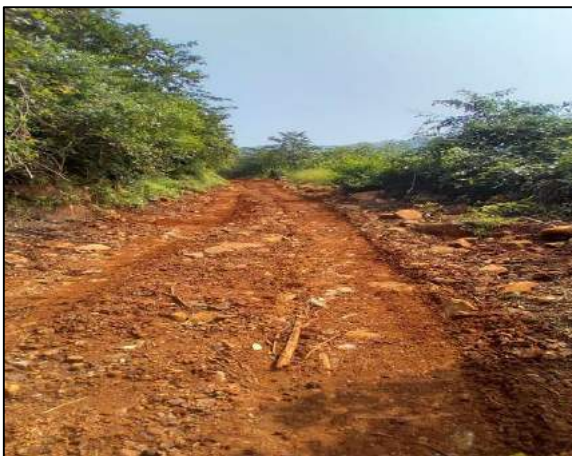
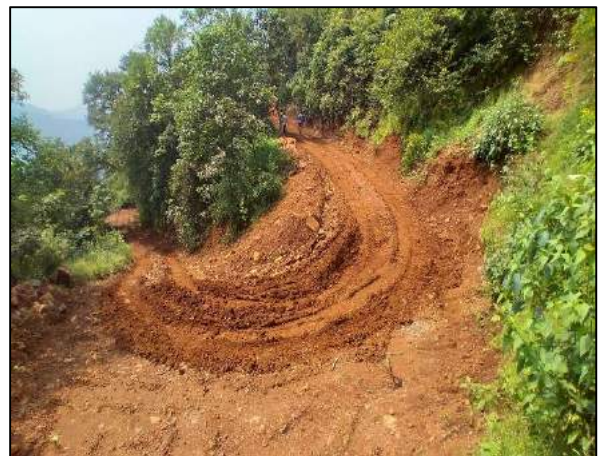
**(Images: After road repair)**

Due to extended return monsoon which started from 08th Oct-20 till 24th Oct-20, an extra efforts puts in repairing of damaged road patches. Road repairing work need to be carried out on repetitive basis from 18<sup>th</sup> Oct until 26<sup>th</sup> Oct-2020.

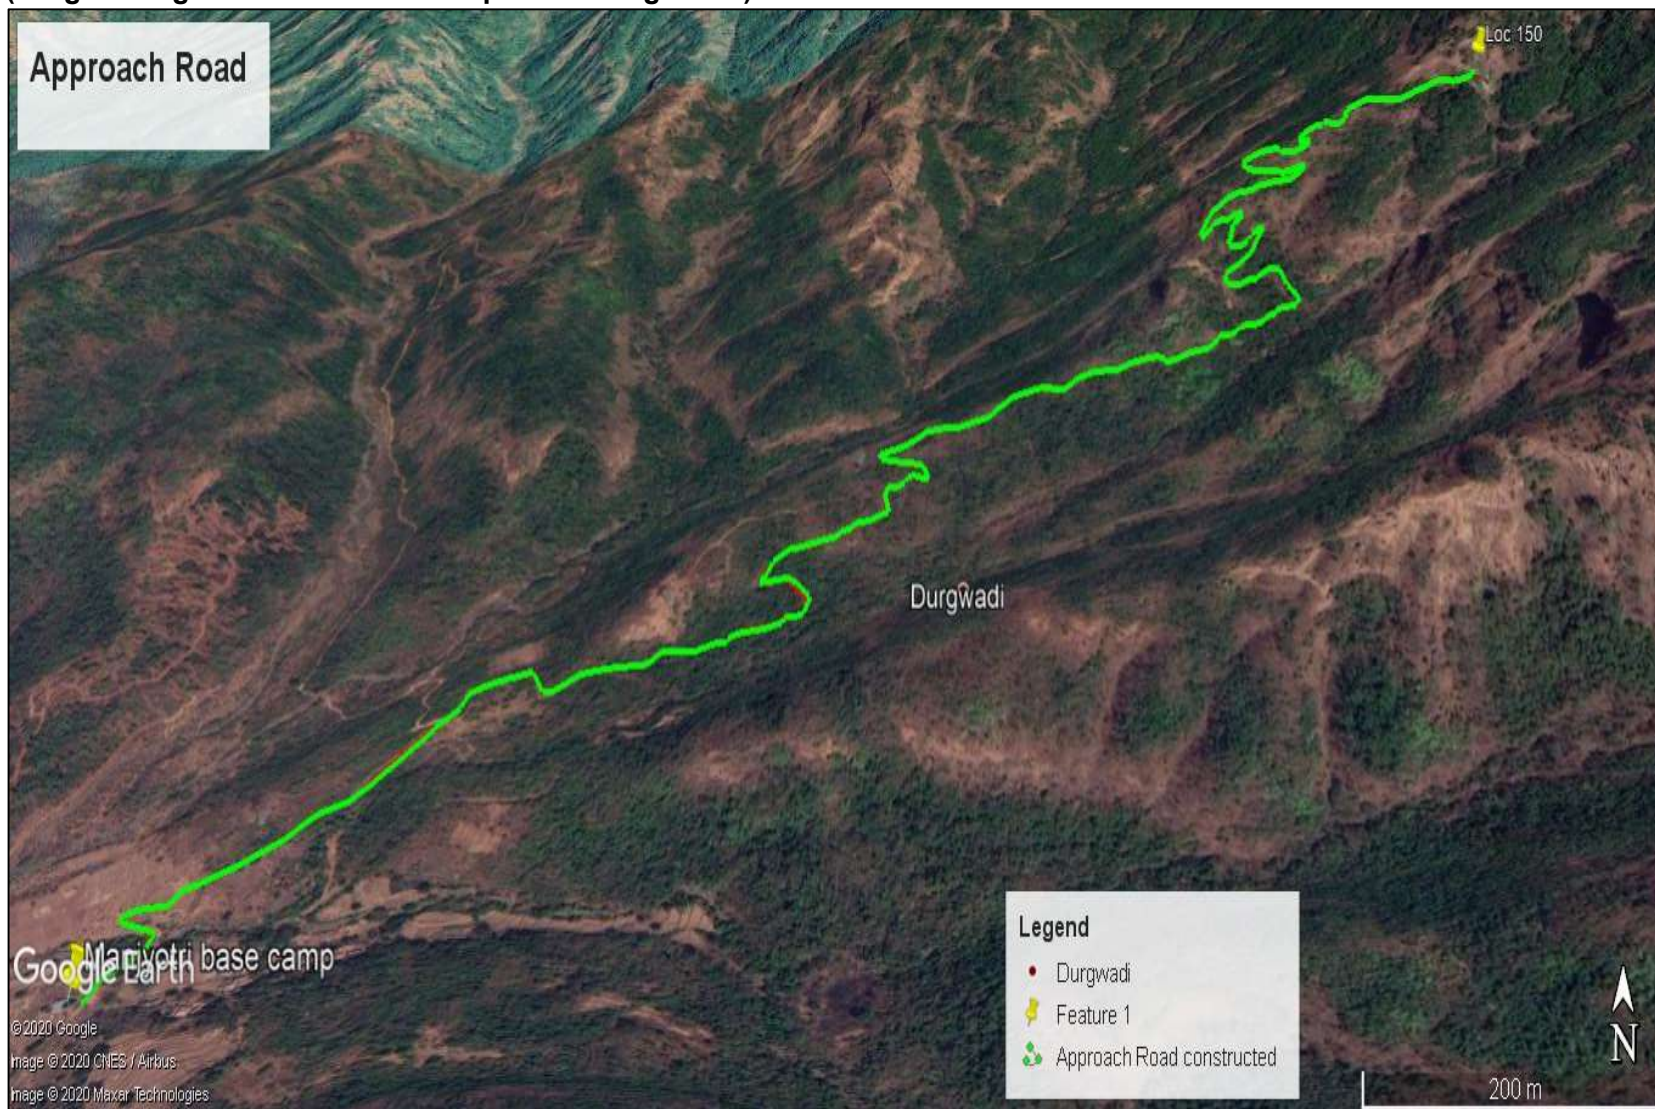
(Image: Google earth view of route passes through hills)

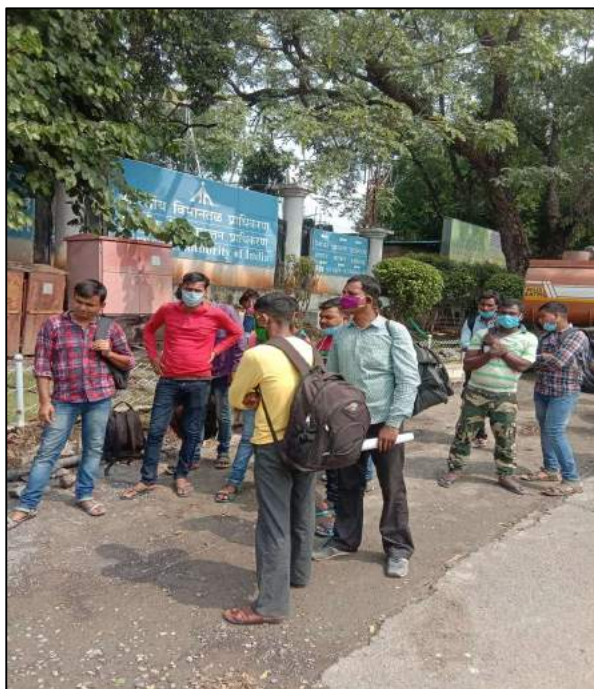
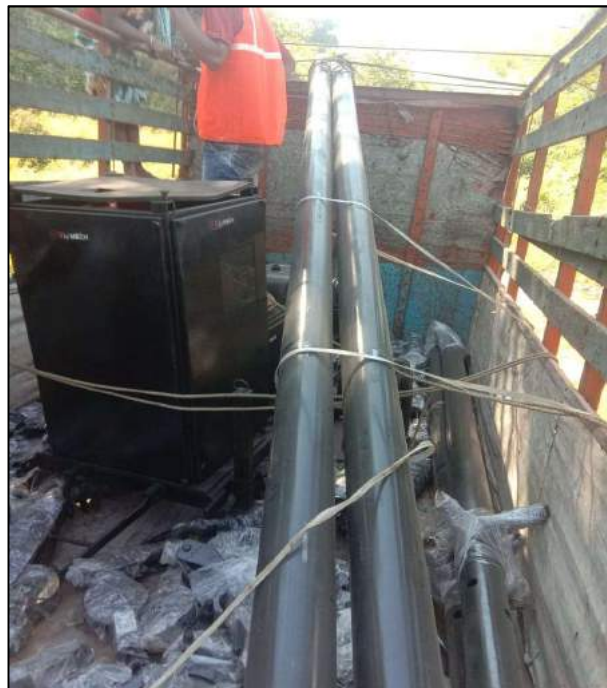
M/s. Greenmint Power pvt Ltd has mobilized restoration manpower as well as T&P's at site on 21<sup>st</sup> Oct-20, however due to continuous raining, the gang stationed at Manjyotri base camp till 27<sup>th</sup> Oct-20. After rebuilding of approach road, T&P along with manpower shifted on hill top nearby to site location.

**(Images: Manpower and T&P mobilisation)**

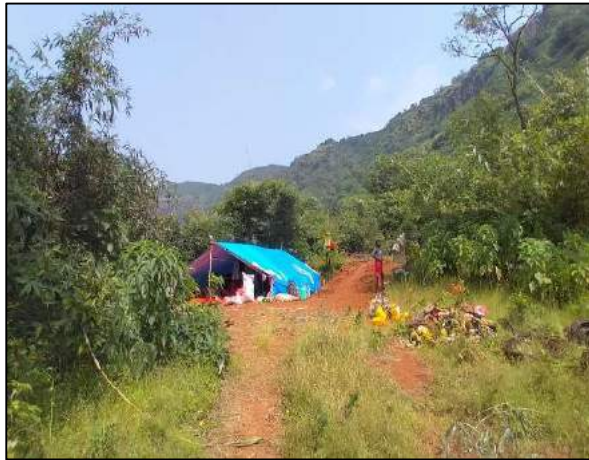
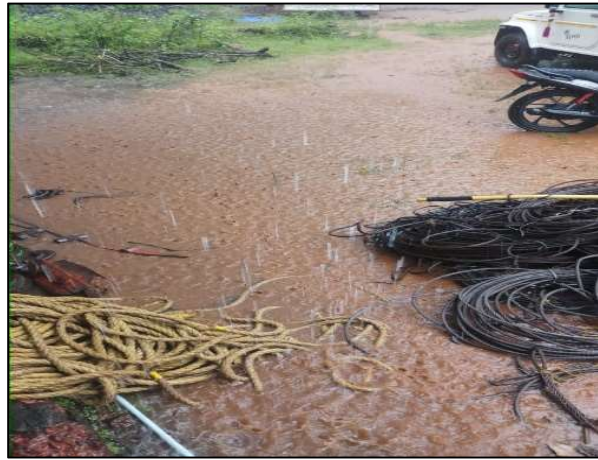
(Images: Camping at site and disturbance by rain)

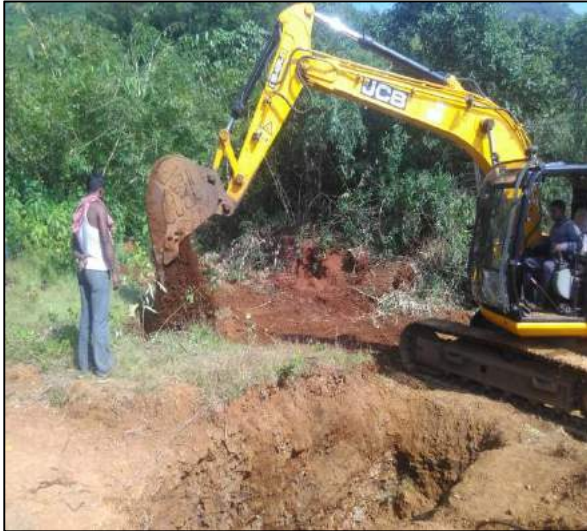
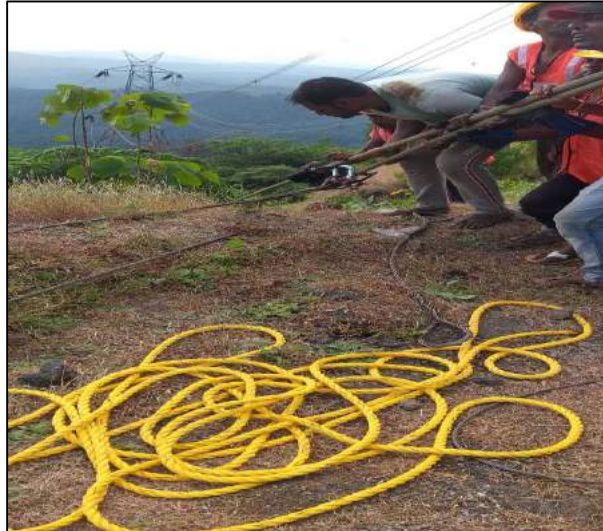
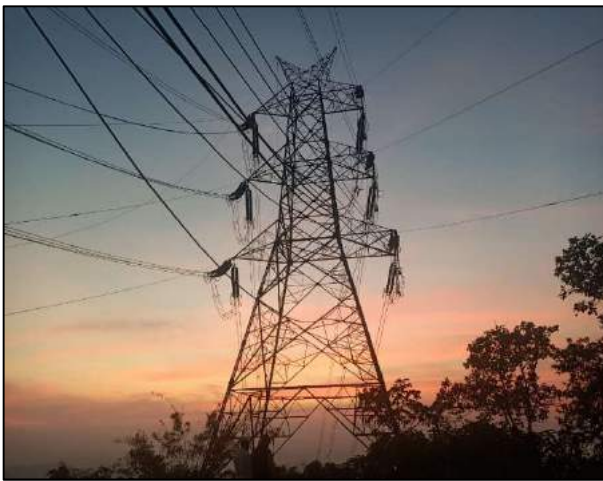
**(Images: Back stay work under progress)**

Before commencing tower de-stringing & dismantling activities of tower 150, in order to save guard adjacent towers (Tower 149 & 151), a temporary guying arrangement need to be provided at location 149 as well as at location 151.

The back stay provided to tower no 149 by using 16mm wire rope slings and turn buckle of capacity of 5 T on all 6 cross arms. However, for Tower no 151 which has encountered with hard rock strata from ground level itself, it was really challenging task to provide back stay, as the tower located in reserve forest area. As the tower is located on the edge of hill top, there was no space to provide back stay (see below images). Hence instead of using wire rope support arrangement, a back stay provided by holding rough sag of conductors by using come along clamps and tied up with big girth trees

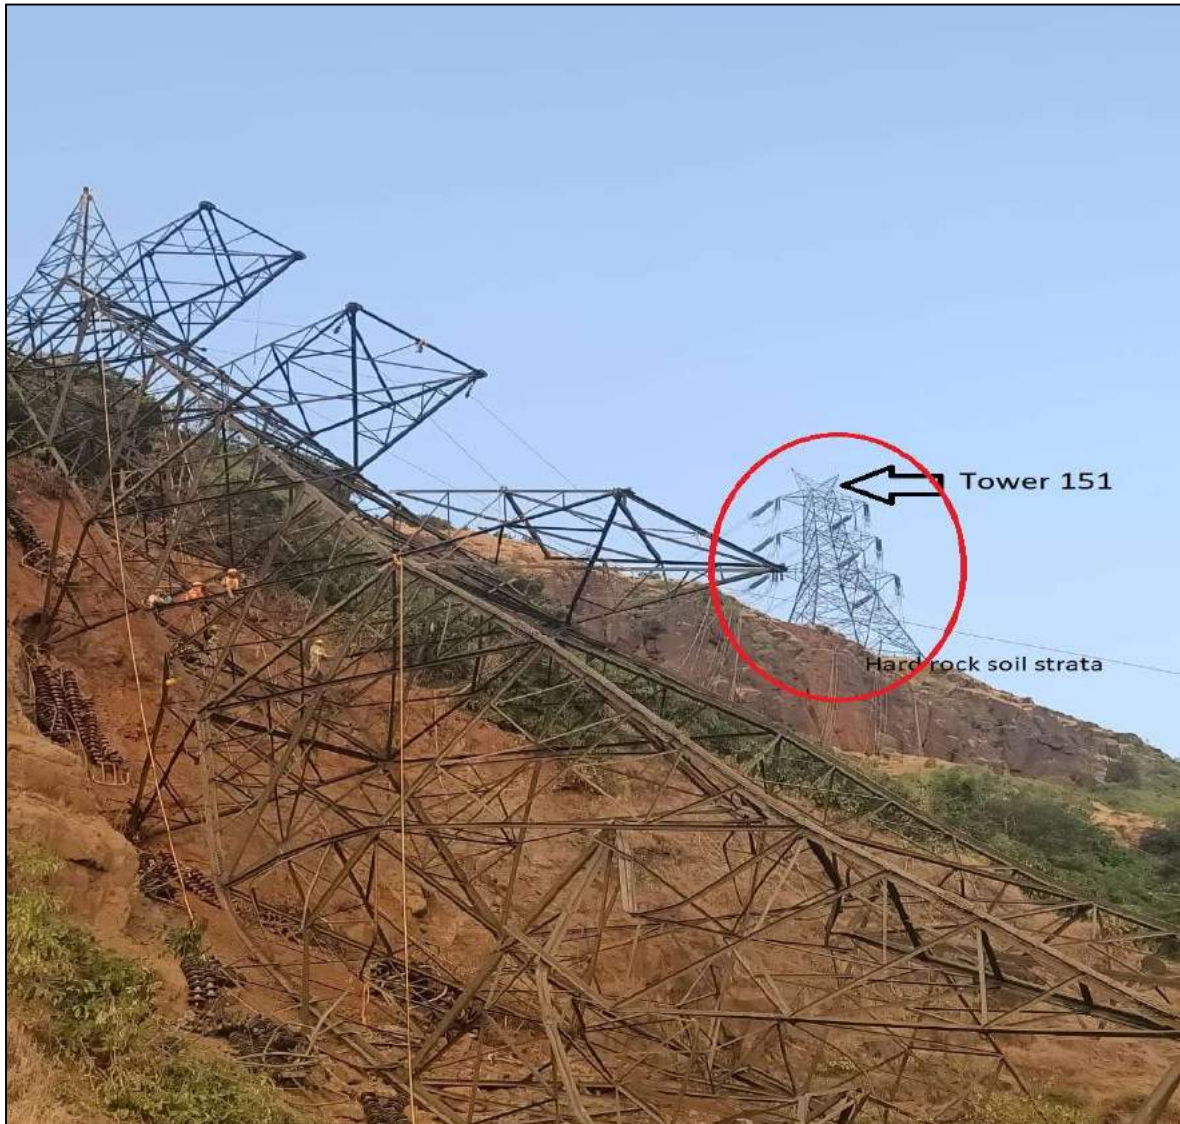
**(Image: Locality of Tower 151)**

in the valley which consumed a lot of energy & valuable time for securing tower position.

Further, To initiate tower dismantling works, we had to secure tower no 150 as well, since tower rested at inclined position on hillock along the leg C & D with undue tension on tower members. The circuit 1 side cross arm pieces were pierced in the hill.

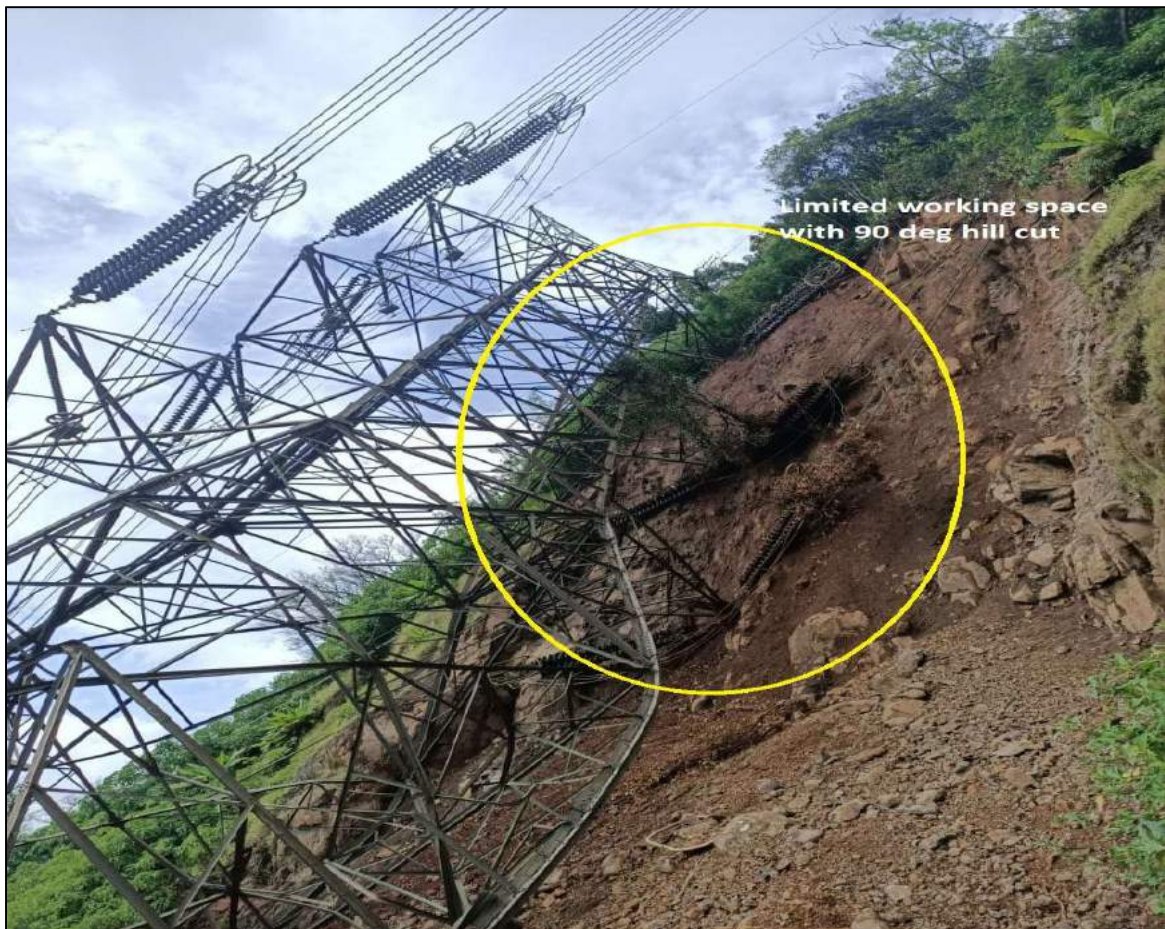
Due to very risky site condition (prone to landslides), the circuit 1 side all phase conductors were pierced in hill, hence it consumed more time to remove hardware's & released conductor from fittings. The soil strata was of dry fissure hence frequent sliding of boulders hampered activity as well. **(See below images)**

The de-stringing of conductor started from span 150-151 & then for span 149-150 ensuring proper sequence of de-stringing in order to execute task in a safe manner. The bottom phases of both circuits released followed by middle & top. During de-stringing works, special attention has been given in the valley section of 150-151 to avoid conductor damages.

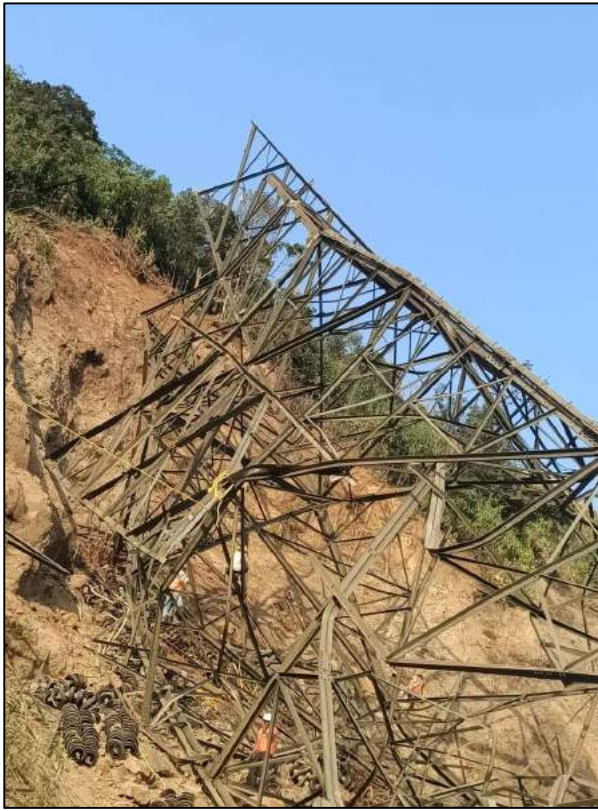
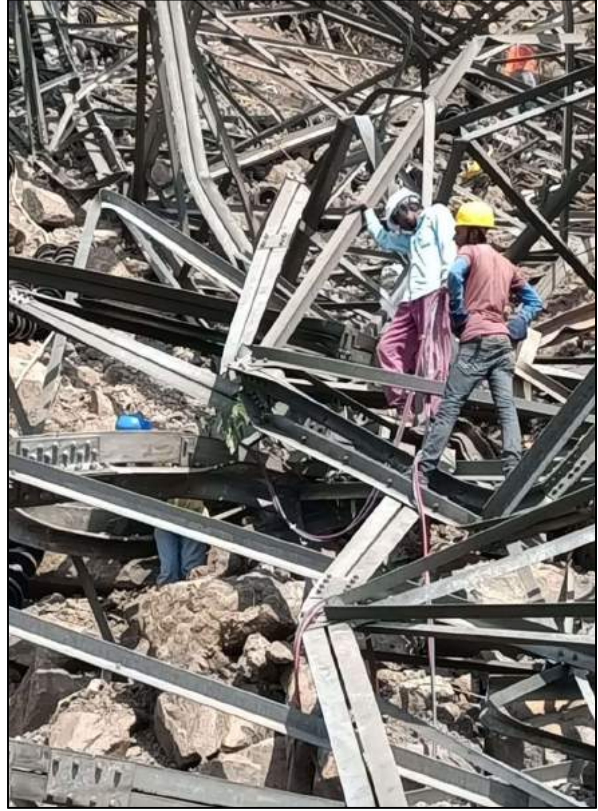
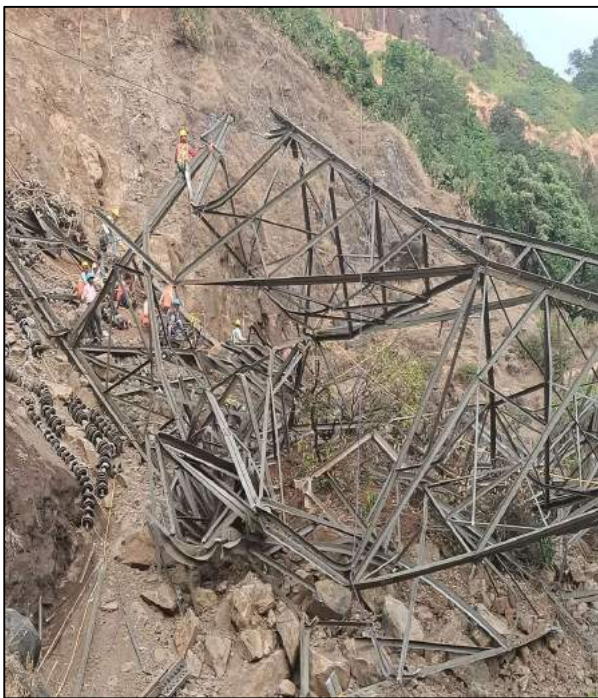
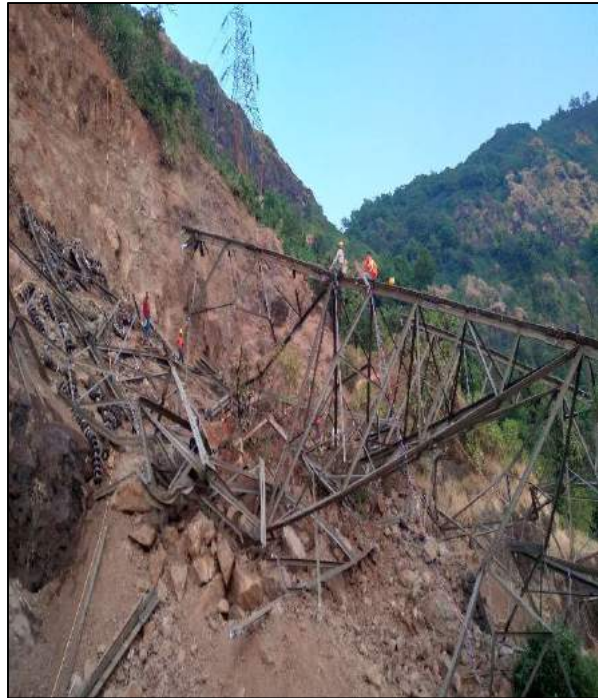
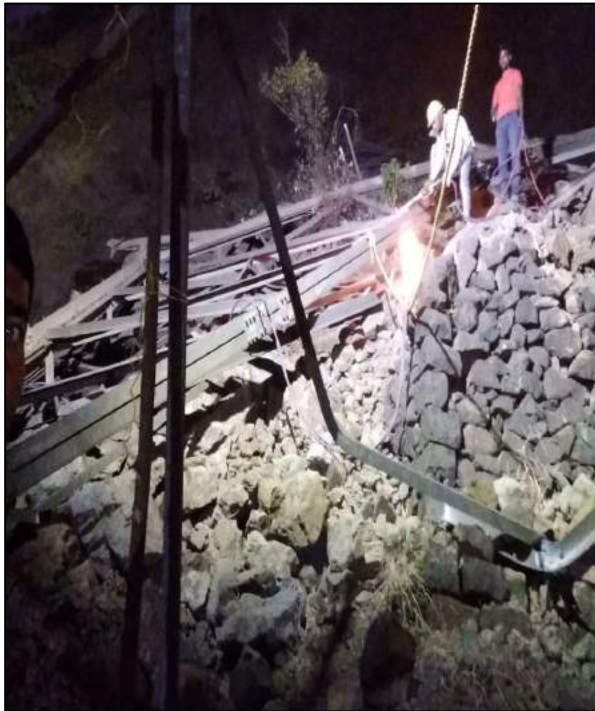
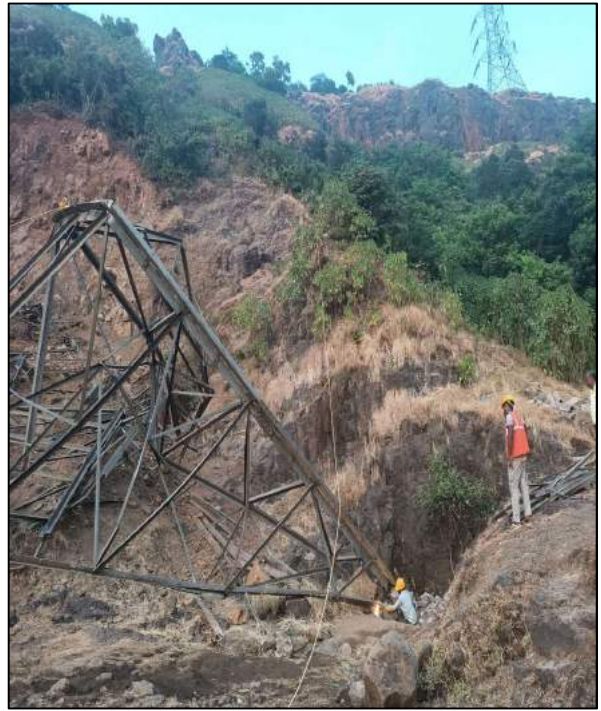
(Images: Tower dismantling by gas cutting)

Dismantled tower parts need to be cleared from site for further dismantling of members.

The dismantling works started on 18.11.2020 and finished on 05.12.2020.

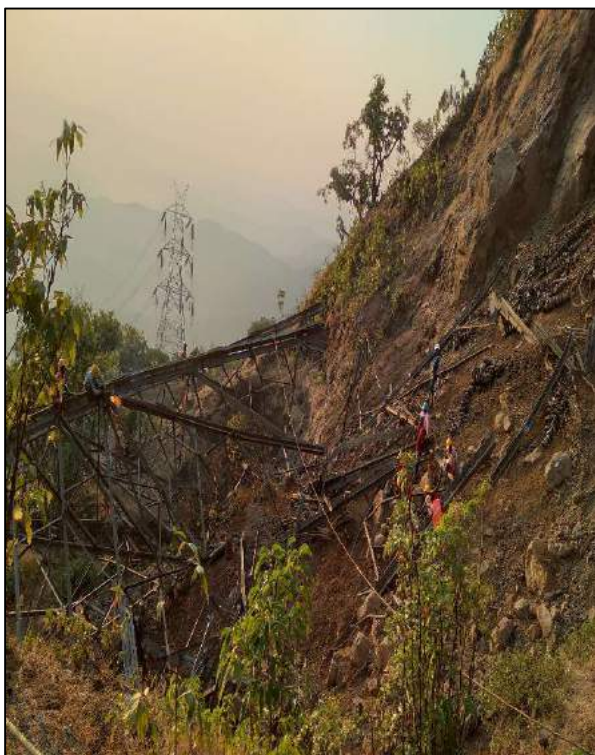
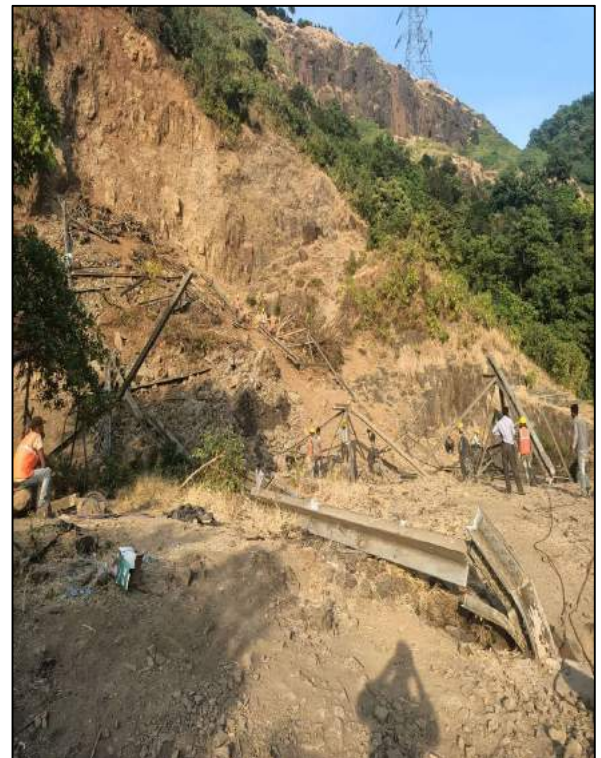
Below bottom cross arm level, all tower parts were dismantled by means of gas cutting method. As the majority tower members buckled/bend, there was huge tension observed while gas cutting. Hence the job was carried out very cautiously to avoid any accidents during cutting of members.

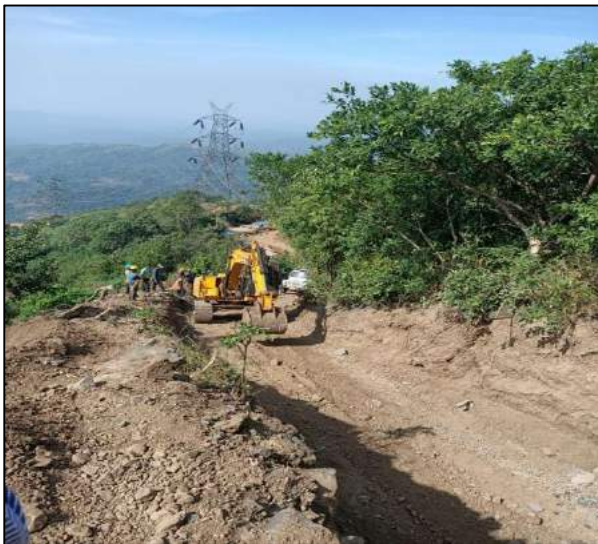
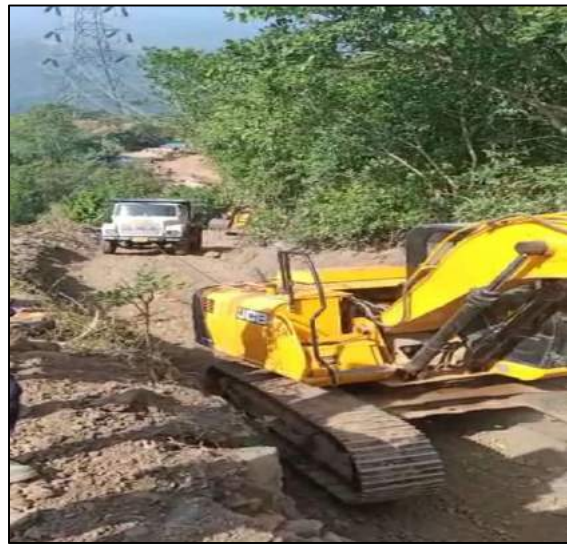
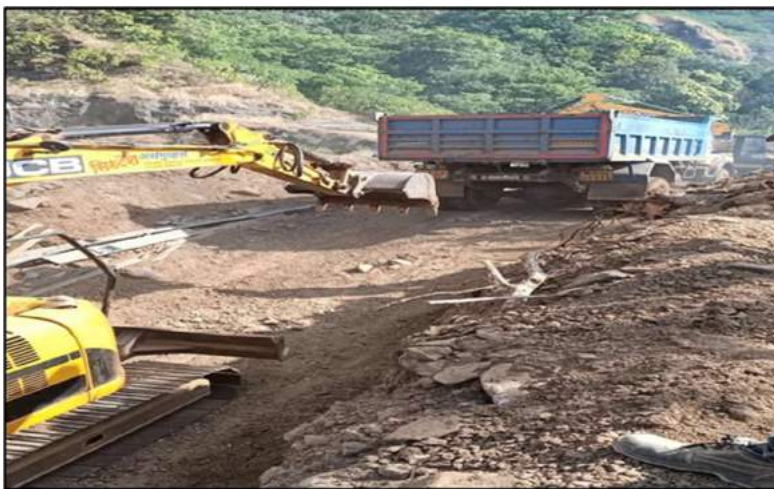
**(Images: Mobilizing machineries with extra support)**

As geographical conditions to access tower location is very extreme, as of now only poclain machineries could able to reach at working site. However, to commence debris removal works, an additional excavator machineries need to be deployed at site like JCB, dumper etc. Since the road gradient for last 100meter section was very stiff, JCB & dumpers have been shifted to the tower 150 by taking support of two poclains (Push-pull).

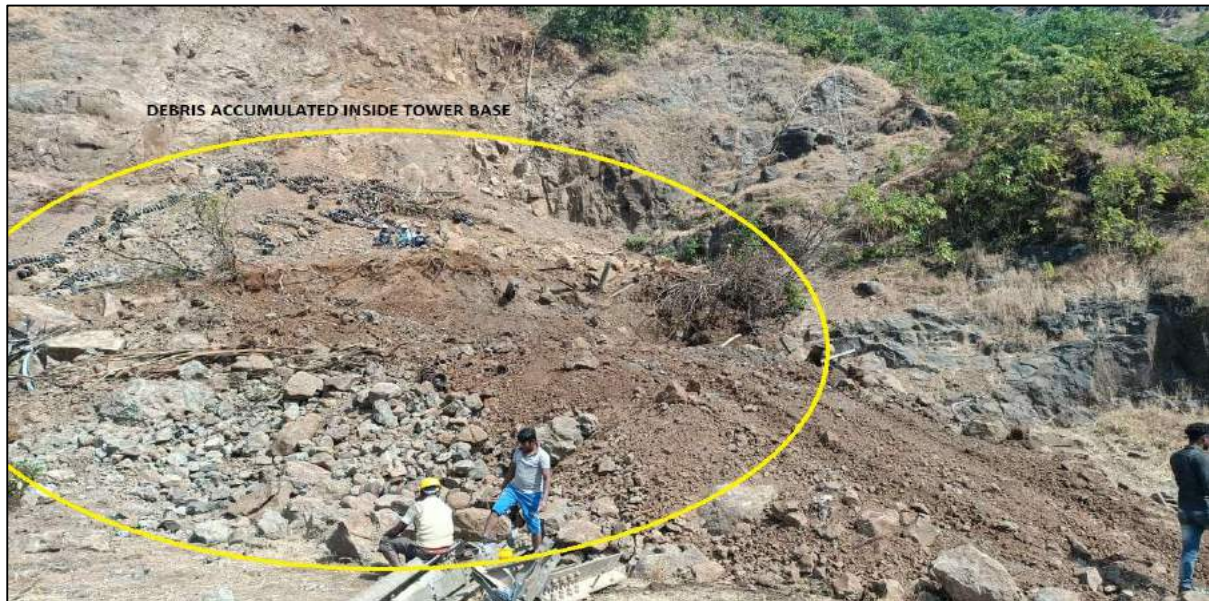
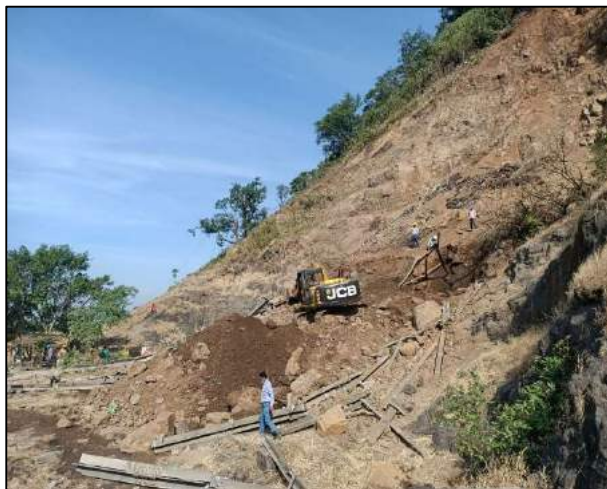
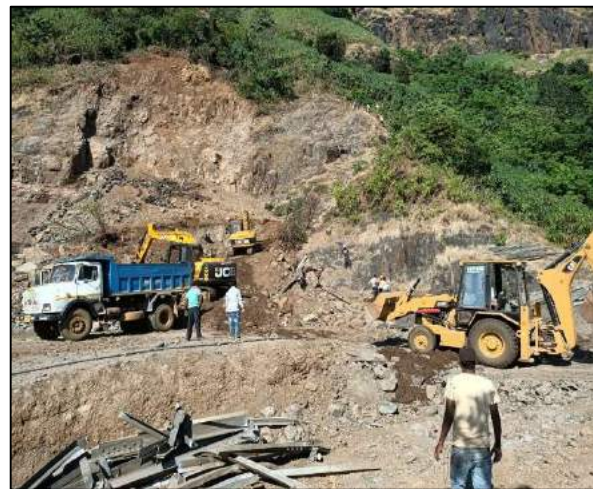
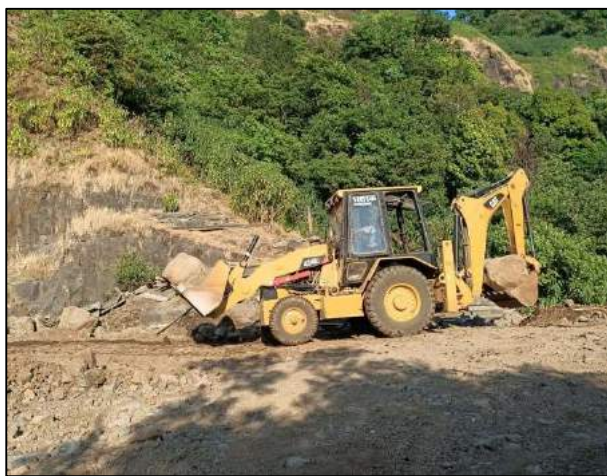
(Images: Debris removal works)

After successful mobilization of excavation machineries, debris removal work started on 06<sup>th</sup> December. The work undertaken in night also to clear huge amount of debris from tower base area at earliest.

The debris removal works finished on 10<sup>th</sup> December 2020 with all coordinated efforts.

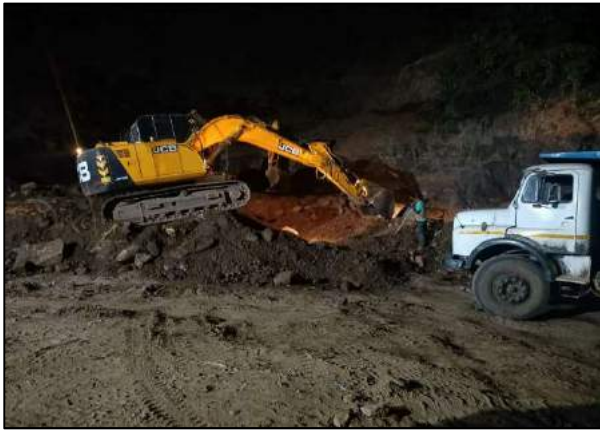
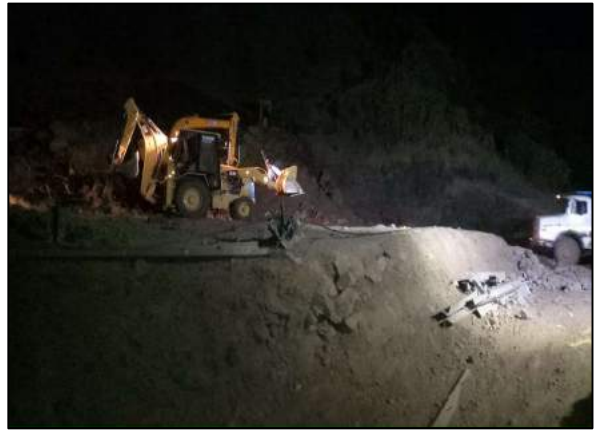
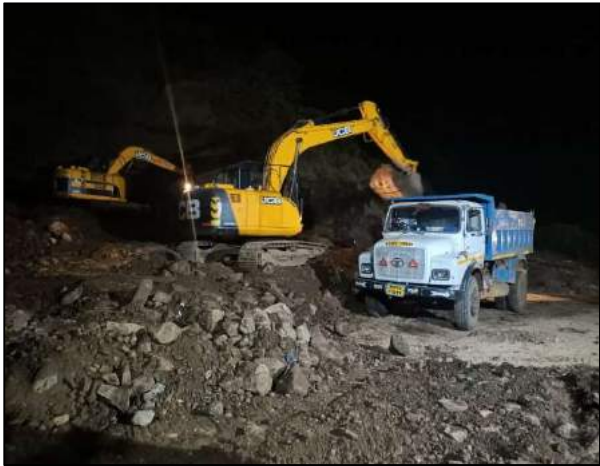
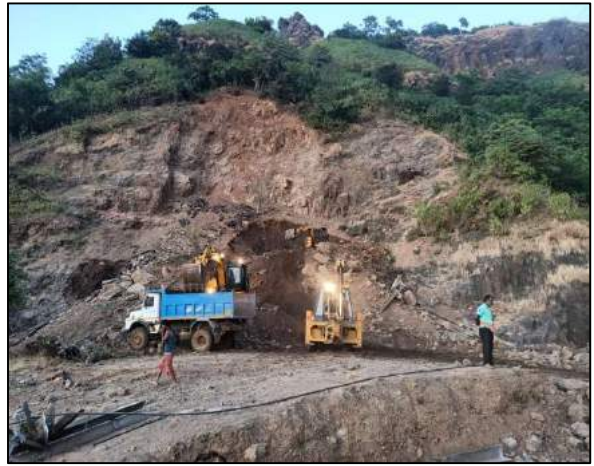
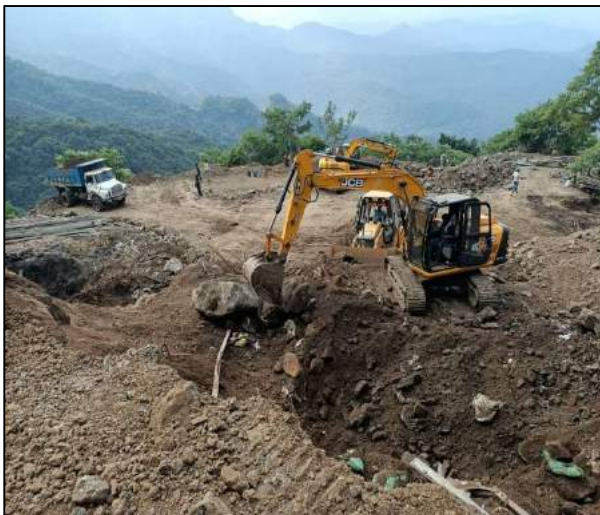
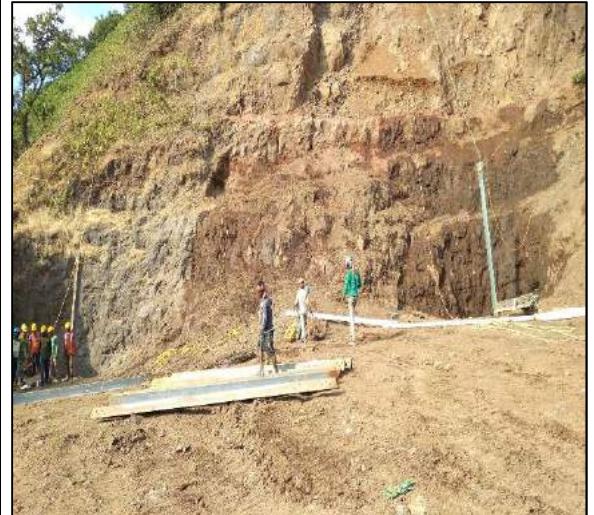
(Images: Late night works)

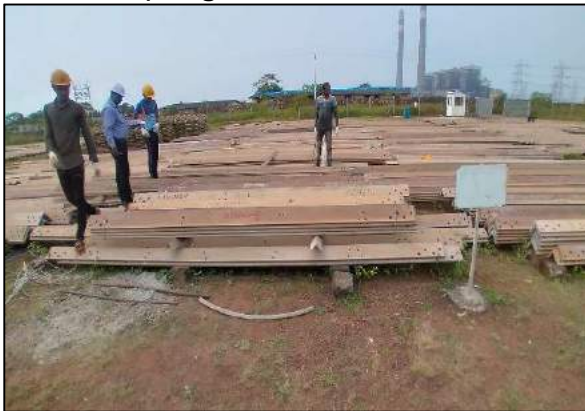
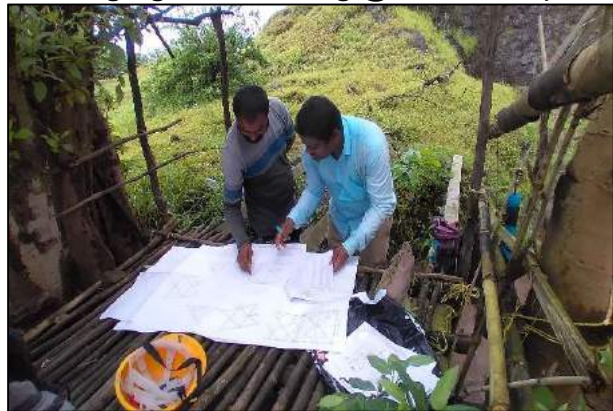
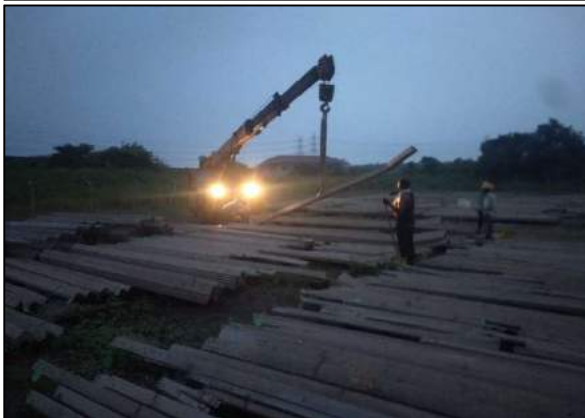
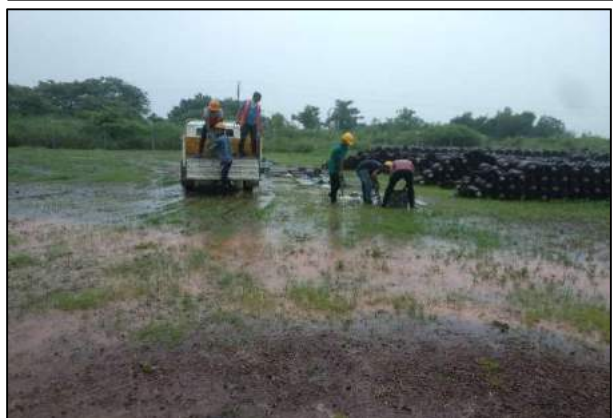
- a) Tower material identification, segregation, loading at JPTL store (Jaigad):  
The JPTL team immediately starts spare material identification works from 3<sup>rd</sup> Oct 2020 at Jaigad stores. About 80 MT tower material including line hardware's, T&P's etc identified, segregated as per BOQ & transported to Manjyoti base camp. The work was hampered severally due to return monsoon, but dedicated team efforts of JPTL team resulted into shifting of required tower material well in advance to commence tower restoration works.

**(Images: Tower material identification, segregation, loading @ JPTL store)**

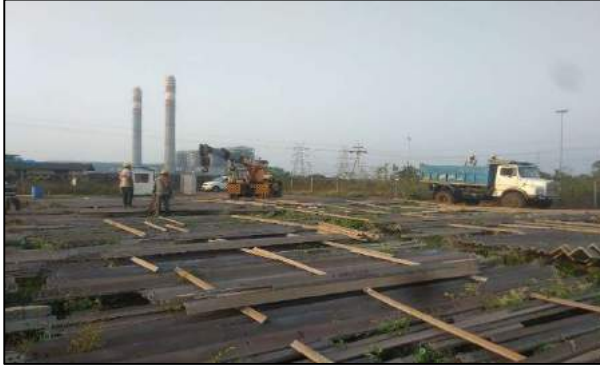
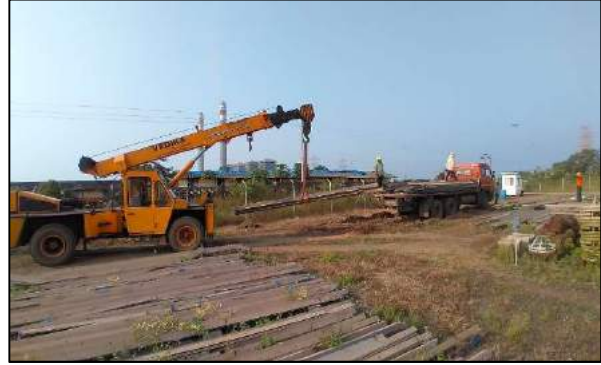
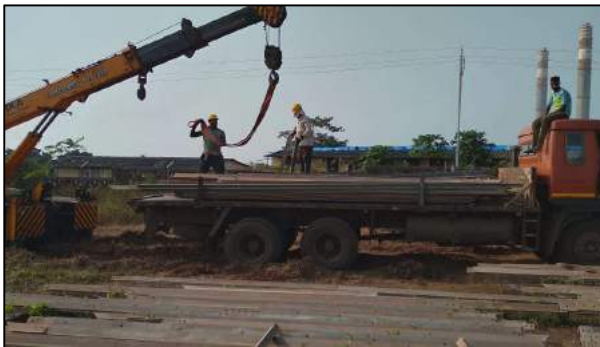
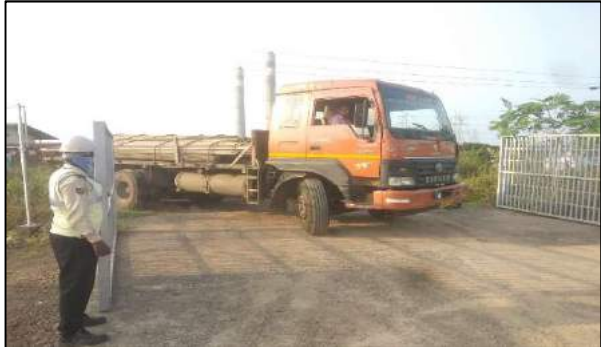
All segregated tower material transported from Jaigad store to Manjyotri through trailers, dumpers & hydra etc by M/s. Kasar construction in safe way.

**(Images: Transportation arrangement from Jaigad Store)**

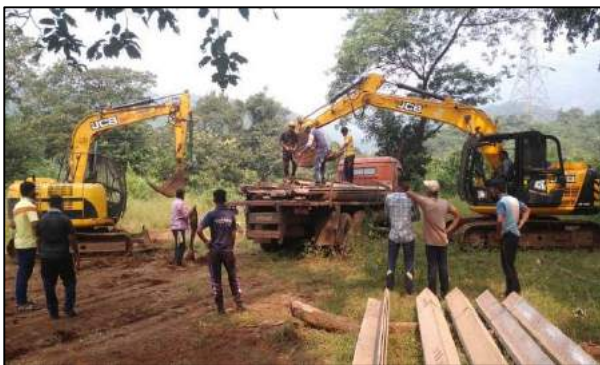
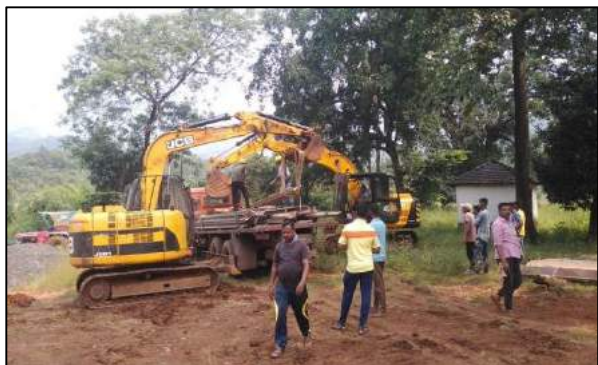
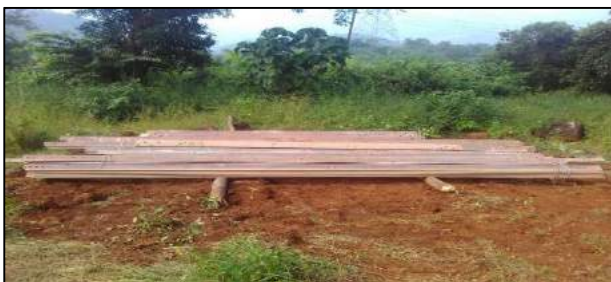
**(Images: Material unloading at Manjyotri base camp)**

*Material transported to Manjotri base camp which is 125 km away from Jaigad store. The road route is of single lane in most the sections with hill & curvy road.*
