**Sub:** Intimation regarding collapse of Tower no. 150 of Jaigad – Karad Transmission line

**Subject: Restoration works of collapsed tower at Location no 150 of 400kV JTPL Jaigad-Karad Line**

A report on restoration of collapsed tower at location 150 of 400kV D/C (Quad) Jaigad-Karad transmission line

By, Jaigad PowerTransco Ltd  
(A Joint venture of JSWEL & MSETCL)

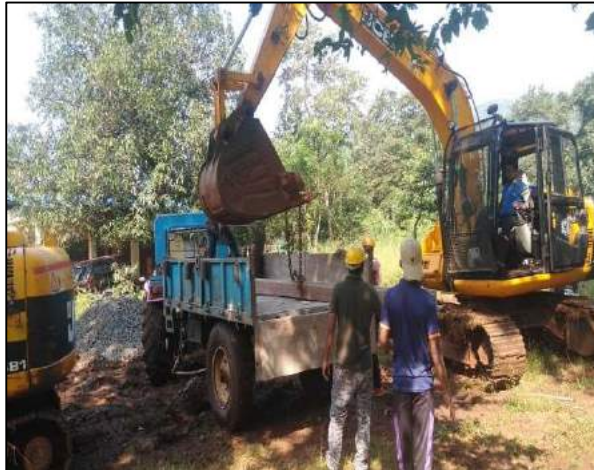
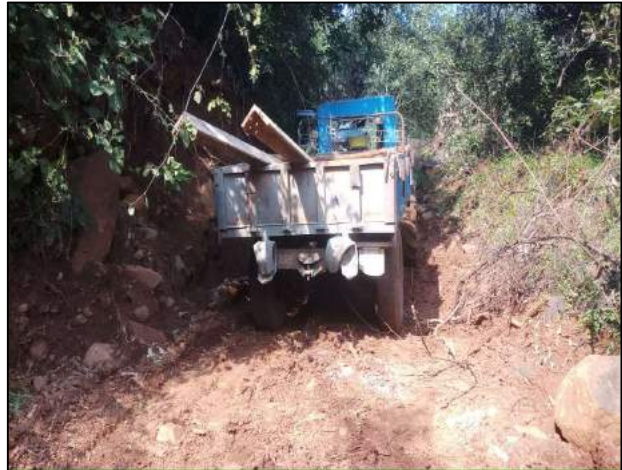
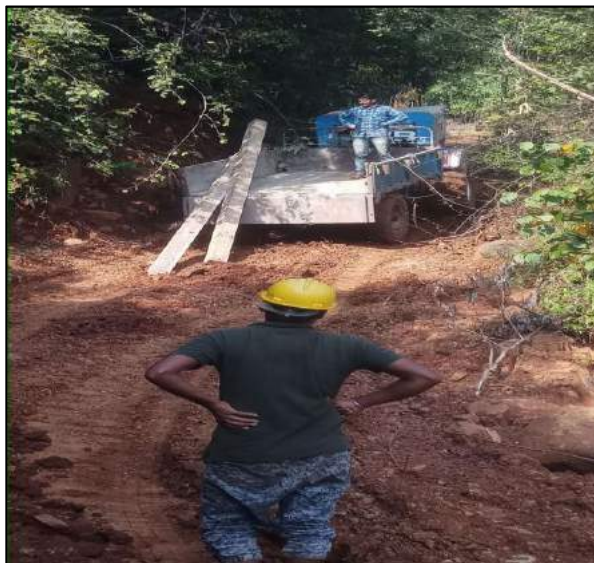
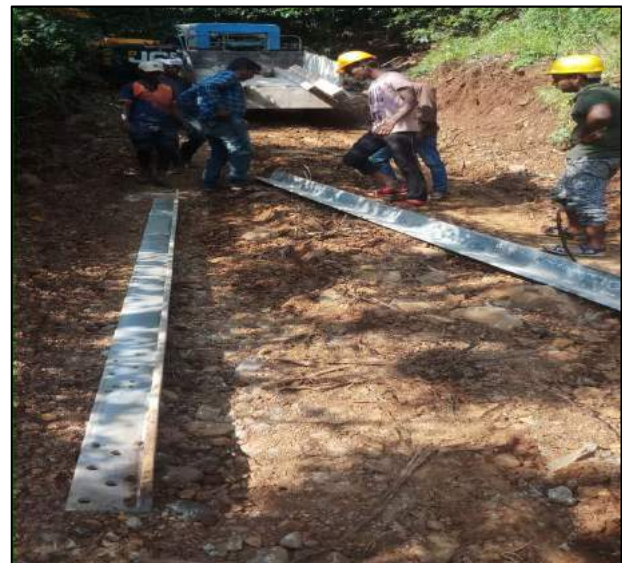
The crucial & risky task among the restoration activity was material shifting from base camp to near tower 149. Due to predominant return monsoon condition in the region, the approach road was severely damaged & repaired repeatedly by poclains. Initially, material shifting was planned by using tractor trolley's, however as the road condition was very slippery & muddy for a prolonged time, shifting commenced through poclains. Fortunately after few days, as the approach road gets dry, we have engaged dumpers for the shifting works & hence we are able to finish material shifting without delaying ongoing restoration activity.

**(Images: Material shifting from base cam to loc 149)**

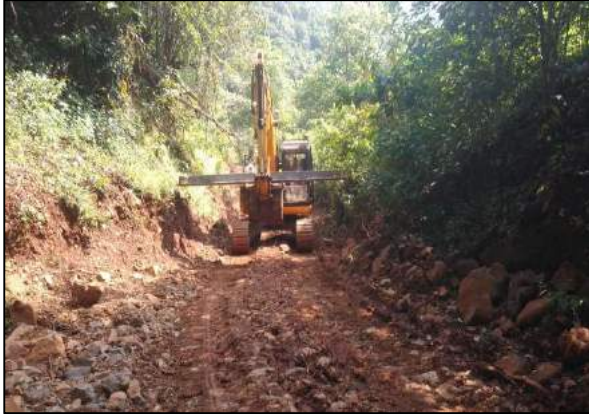
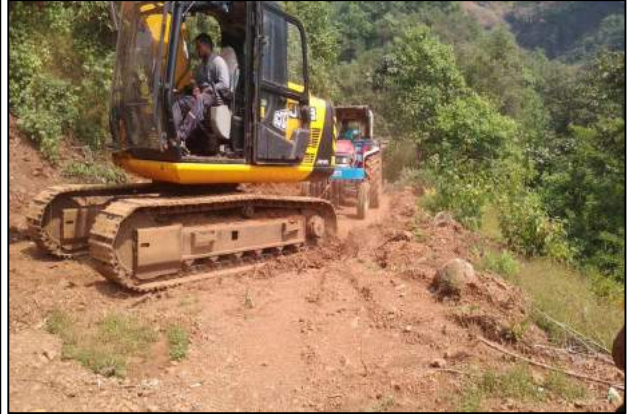
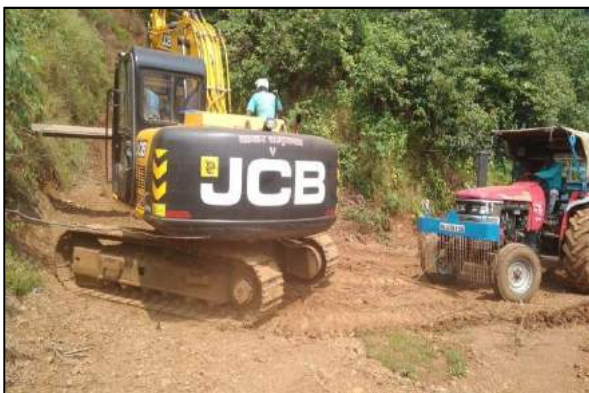
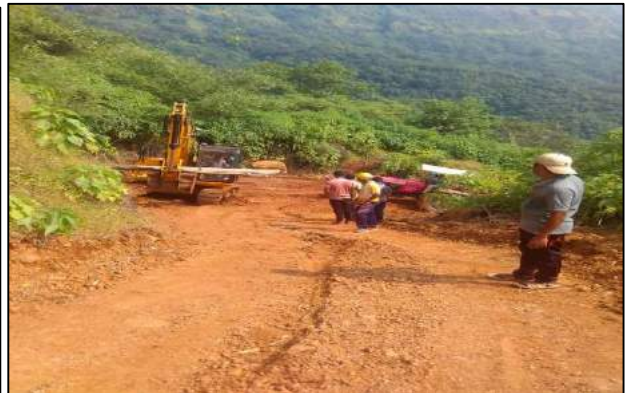
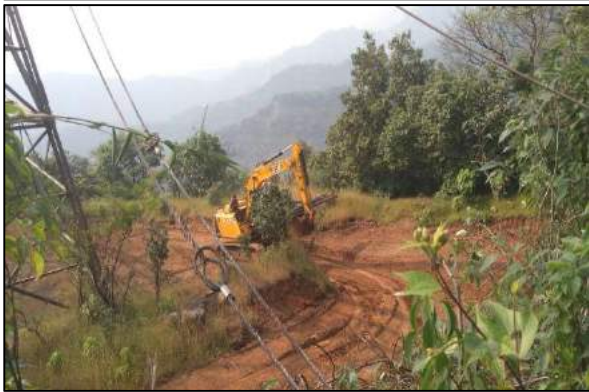
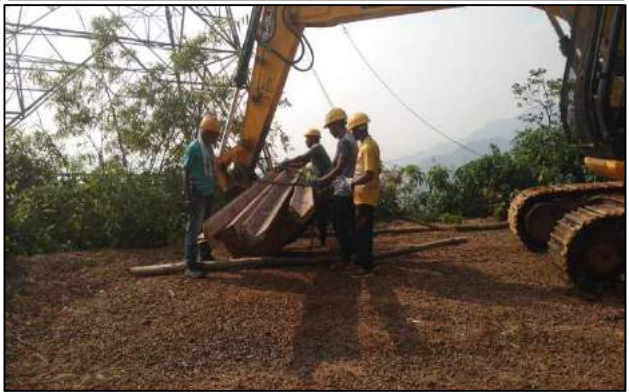
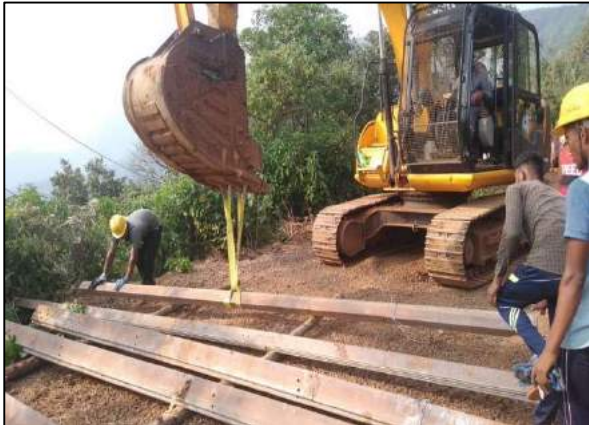
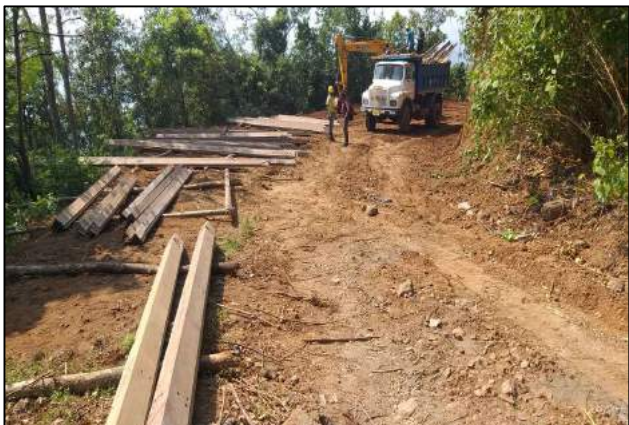
(Images: Difficult to transport by tractor)

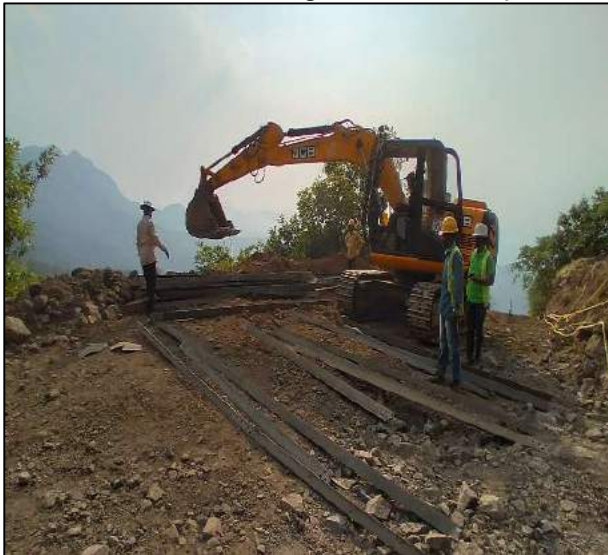
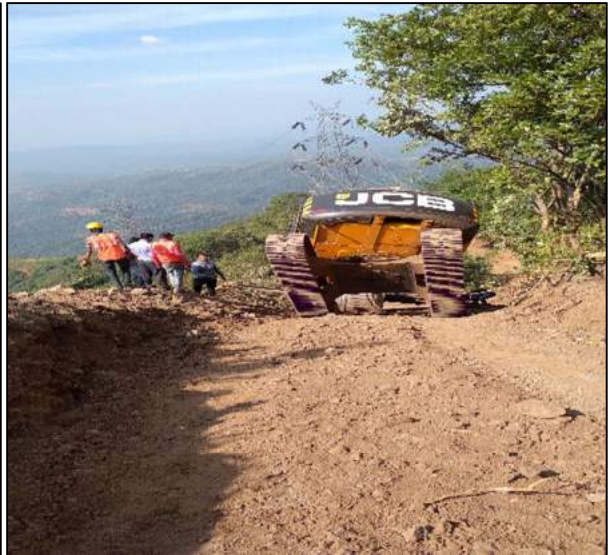
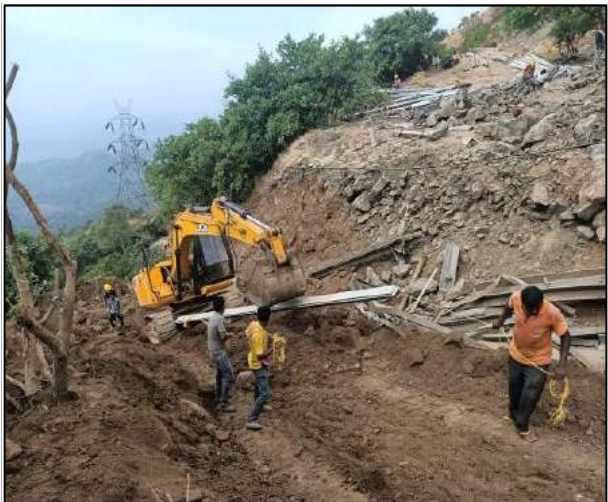
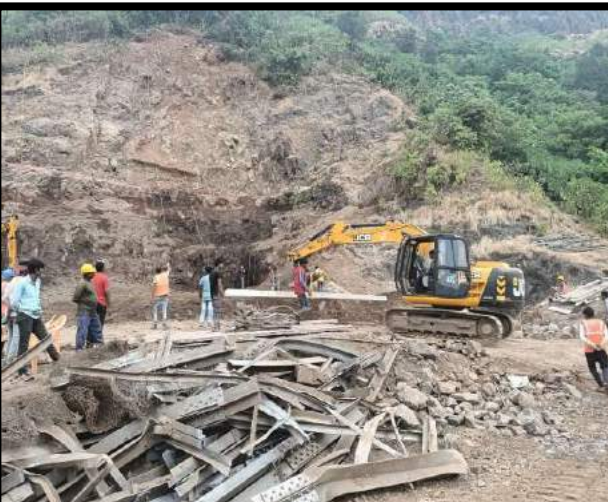
The most crucial part of restoration is material shifting from tower 149 to tower 150. As the last 100 m road section for loc 150 has very high gradient, material shifting even by engaging poclains also seems to be very difficult. At one instance, poclains was turn upside down and about to collapse in deep valley but somehow operator has managed to control it by front bucket while shifting of scrap material. So, shifting in the specific section carried out in very cautious manner by further reducing stiff gradient.

Due to space constraints at location 150, every activity executed in series. ie. We waited for shifting of tower erection material till stub repairing work get completed. Due to the high gradient of road access to tower location, JCB & 2 nos Poclain deployed at site for tower material shifting in addition to head loading of heavy tower leg members. Further, as there was a very limited storage space at location 150, Section Wise shifting of Tower material from location 149 to actual working site undertaken by means of Poclain as well as head loading wherever required.

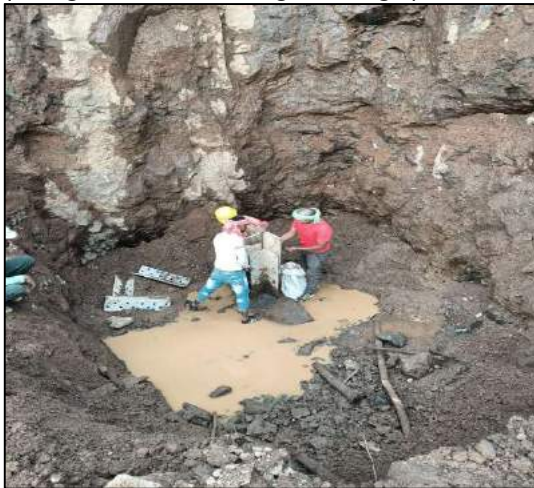
(Leg-C)

During visual inspection before excavating all tower legs, it was assessed to repair all stubs by providing stub joints or foundation re-casting subjected to extent of damages. However, after opening of all 4 legs it was found that only Leg-A need to strengthen. Accordingly, stub strengthening work carried out on Leg-A.

Cement concrete of chimney broken up to 1.5 meter (till bended portion) from stub top level. An existing damaged section of stub cut for about 1.5 meter & jointed by new stub with similar dimension. Stub setting checks have been completed by surveyor 9by confirming stub levels, diagonal & back to back measurements of stubs)

Concerting of M50 grade of existing chimney size completed in all respect.

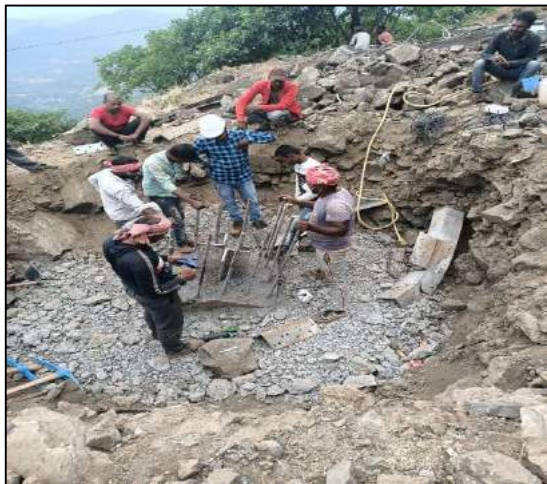
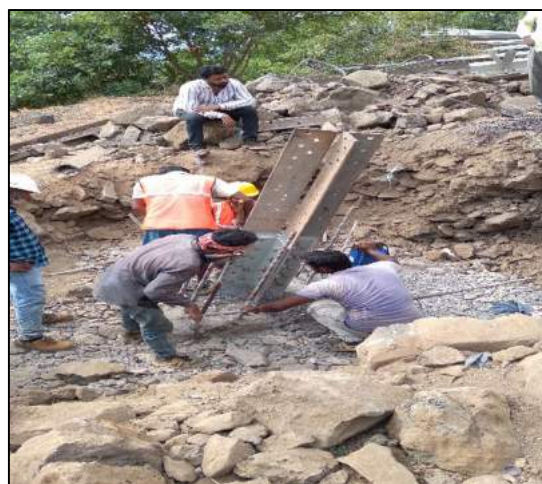
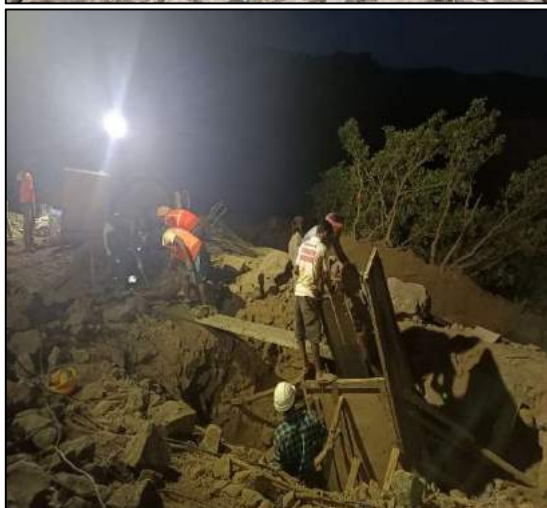
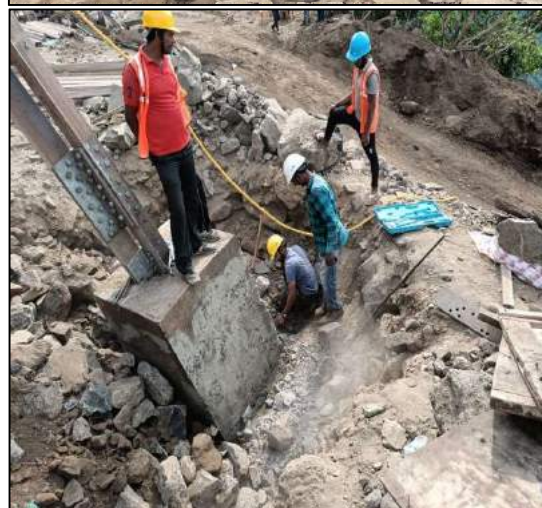
Onsite fabrication works carried out during stub strengthening by using magnetic drill machine, cutting & grinding machine etc.

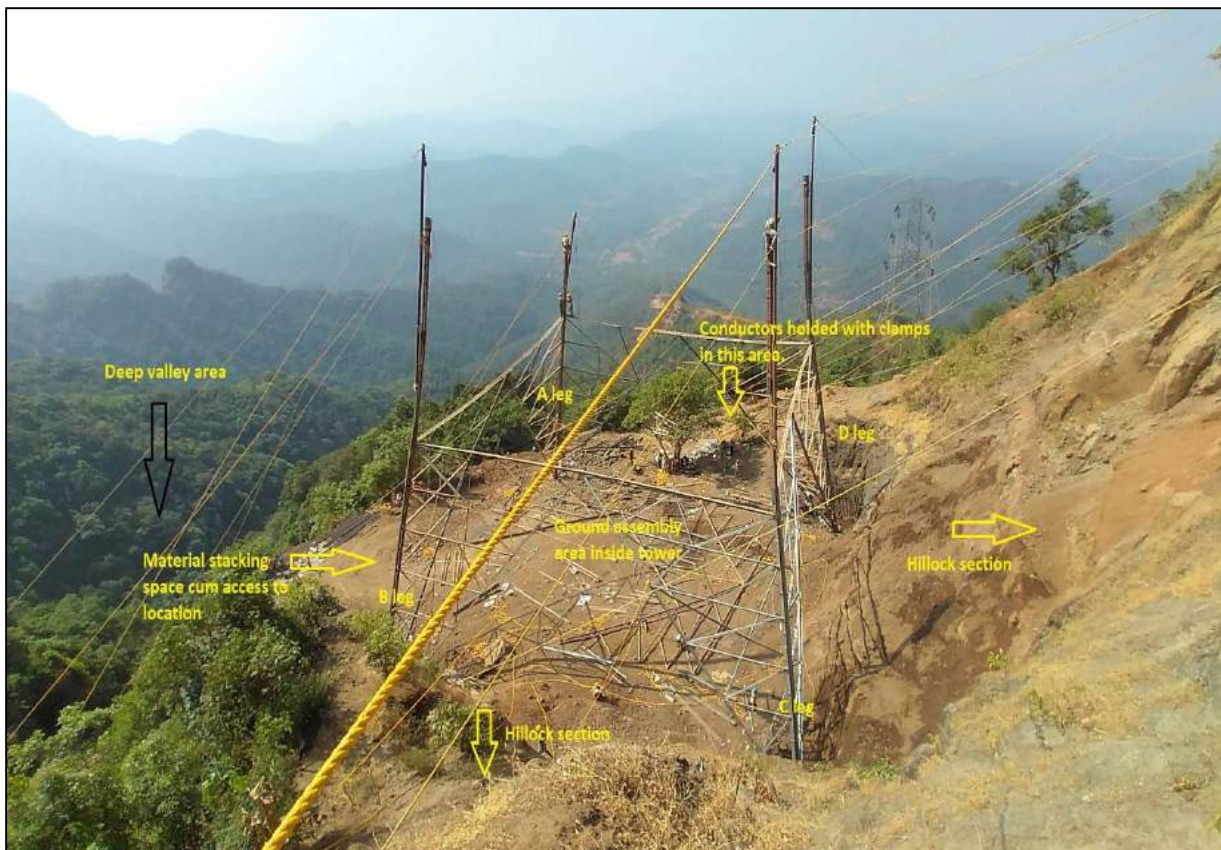
(Image: Showing space constraints at the tower 150)

Due to challenging terrain of sahyadri hills, we have very limited working space for tower erection activity. Ground assembly of main leg extension members, K-frames, cages etc prepared inside the tower base area and section wise material stacking & segregation carried out alongside of leg A-B (exposed towards deep valley of about 2000ft).

We have prepared a temporary platform by filling of earthen material to stack erection material. Lifting/erection of assembled sections has been carried out from inside area of tower body, not from outside of tower body as in conventional method due to space constraints along the leg B-C, C-D & A-D.

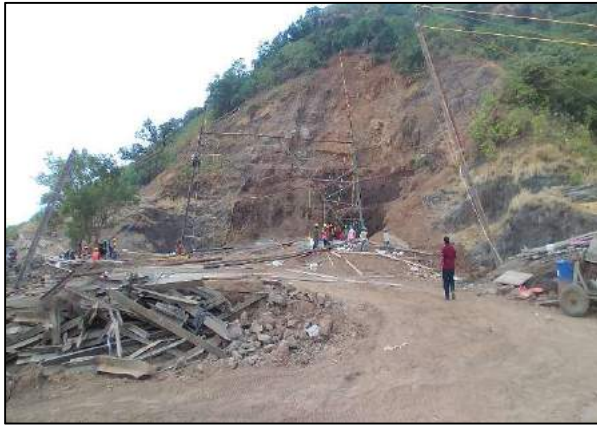
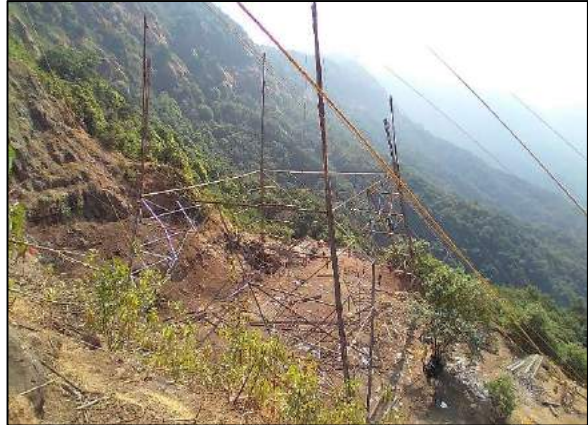
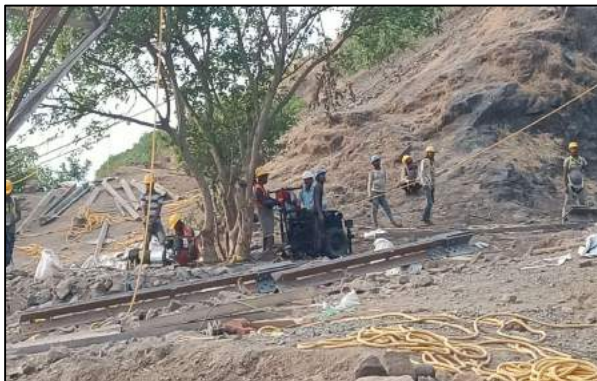
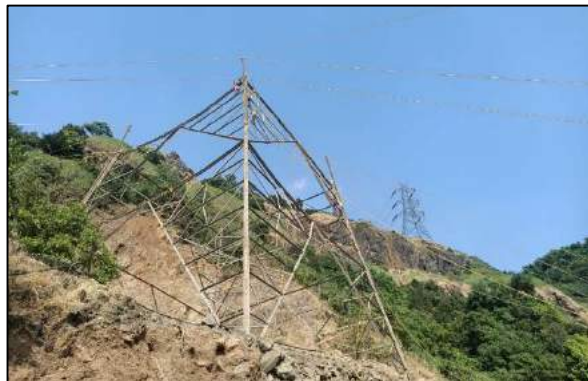
(Images of Tower erection works)

(Winch Machines)

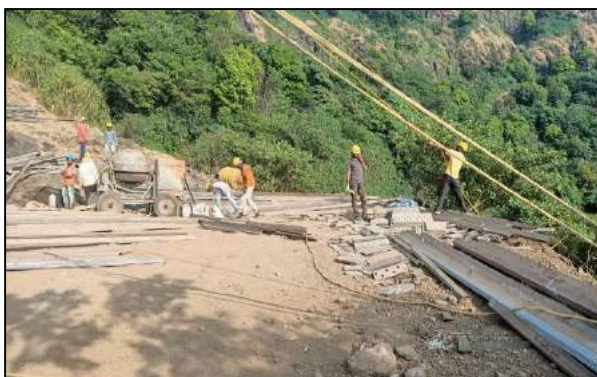
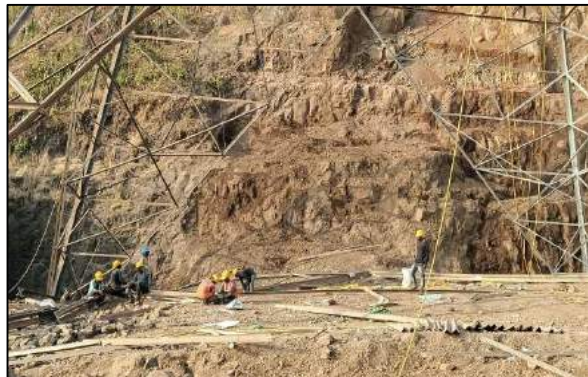
The shifted tower material then segregated by JPTL team as per drawings and handed over to the erection gang.

(Material segregation)

(Ground assembly)

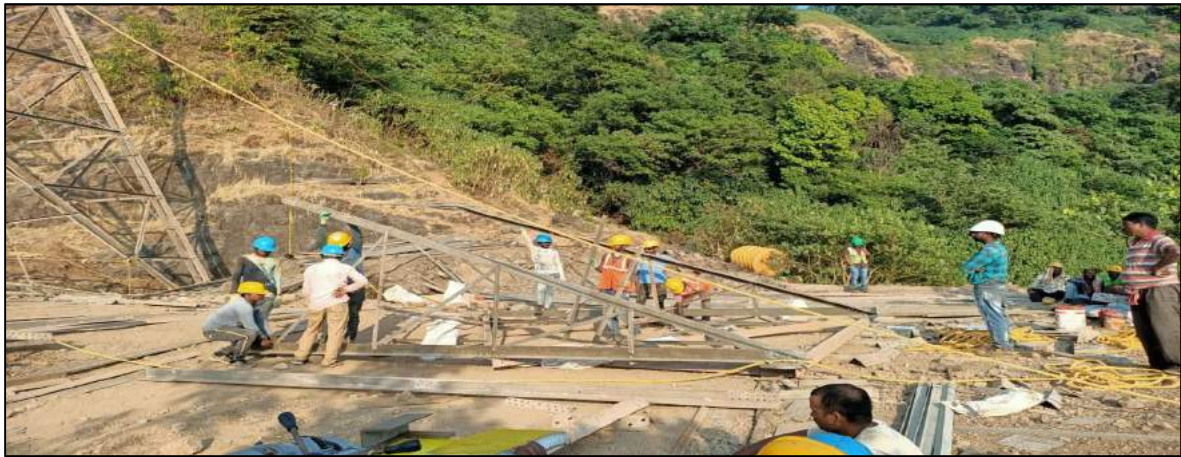
In the meantime, scrap generated from tower has been shifted to clear space occupied by scrap material nearby tower location. Further onsite tower fabrication set up fixed for minor fabrication on tower parts as per site requirement.

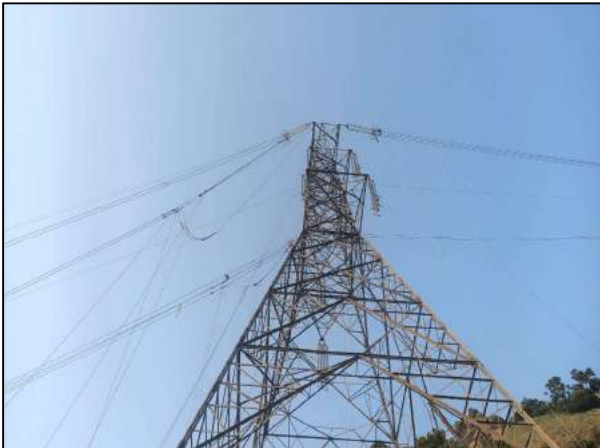
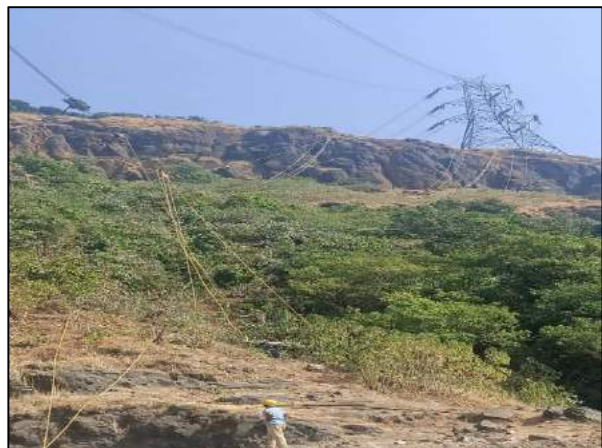
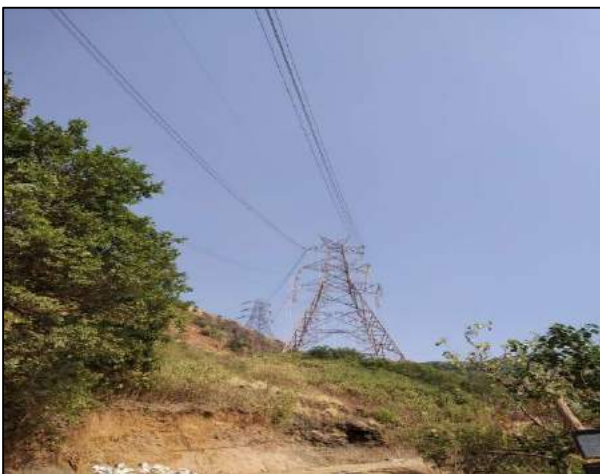
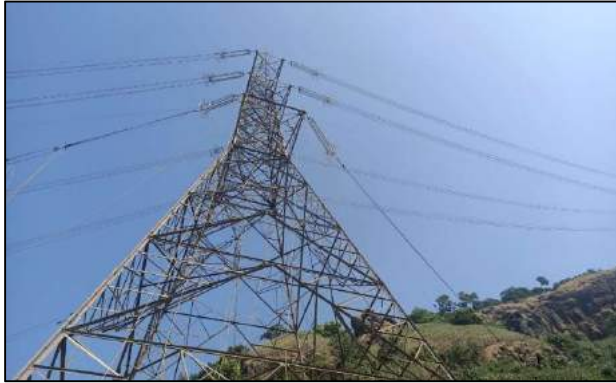
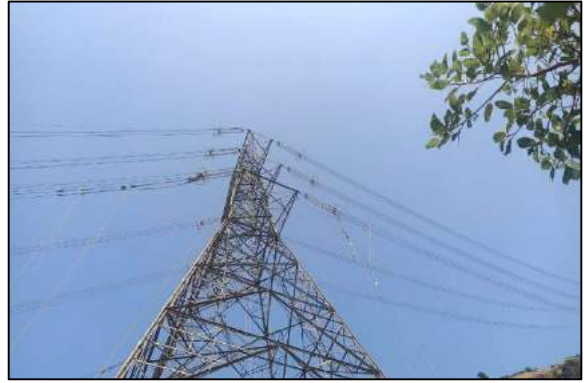
**(Images: stringing works)**

A proper stringing sequence has been followed while final sagging of conductors & earth wires. The rough sagging done for conductors for span 149-150 to ensure back stay for tower 150, before final sagging of span 150-151, as the tower 151 is on higher elevation than tower 150 & 149.

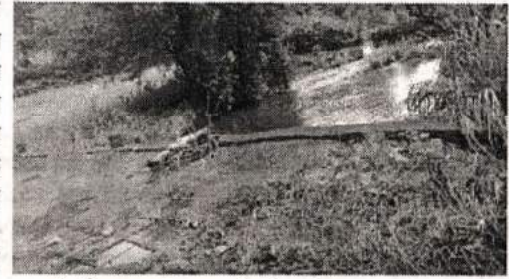
**चिपळूण :** दोन दिवसांपूर्वी कोसळलेल्या मुसळधार पावसात तालुक्यातील ओमळी-पवारवाडी व नारदखेरकी या दोन गावांना जोडणाऱ्या वहाळावरील कॉजवेच्या दोन्ही बाजूचा भराव पूर्णपणे वाहून गेला आहे. त्यामुळे हा कॉजवे वाहतुकीसाठी धोकादायक व अडचणीचा बनला आहे.

**ओमळी पवारवाडी व नारदखेरकी या दोन गावांना जोडणाऱ्या वहाळावरील कॉजवेच्या दोन्ही बाजूचा वाहून गेलेल्या भराव.**

आंबवकरवाडी, ताम्हणमळा-साहाणवाडी येथील शेतकऱ्यांना भातशेतीची वाहतूक करण्यासाठी फार मोठी अडचण निर्माण झाली आहे. तर वाहतुकीच्या दृष्टीनेही हा कॉजवे धोकादायक बनला आहे. या कॉजवेच्या ओमळी पवारवाडीच्या बाजूला अजून दोन व नारदखेरकी गावाच्या बाजूने दोन नाल्यांची आवश्यकता आहे. तरी जि.प. बांधकाम विभागाने याकामी गांधार्याने लक्ष घालून या कॉजवेचे काम तातडीने हाती घ्यावे, अशी मागणी केली आहे.
