**Subject: Compliance status of Environmental Clearance for Captive jetty at Dharamtar, Dolvi, Raigad, Maharashtra**

## COMPLIANCE STATUS OF CAPTIVE JETTY AS PER ENVIRONMENTAL CLEARANCE UPTO NOVEMBER, 2018

*Report on*  
**Monitoring - Expansion of Dharamtar Jetty facility  
at Dolvi, Raigad, Maharashtra**

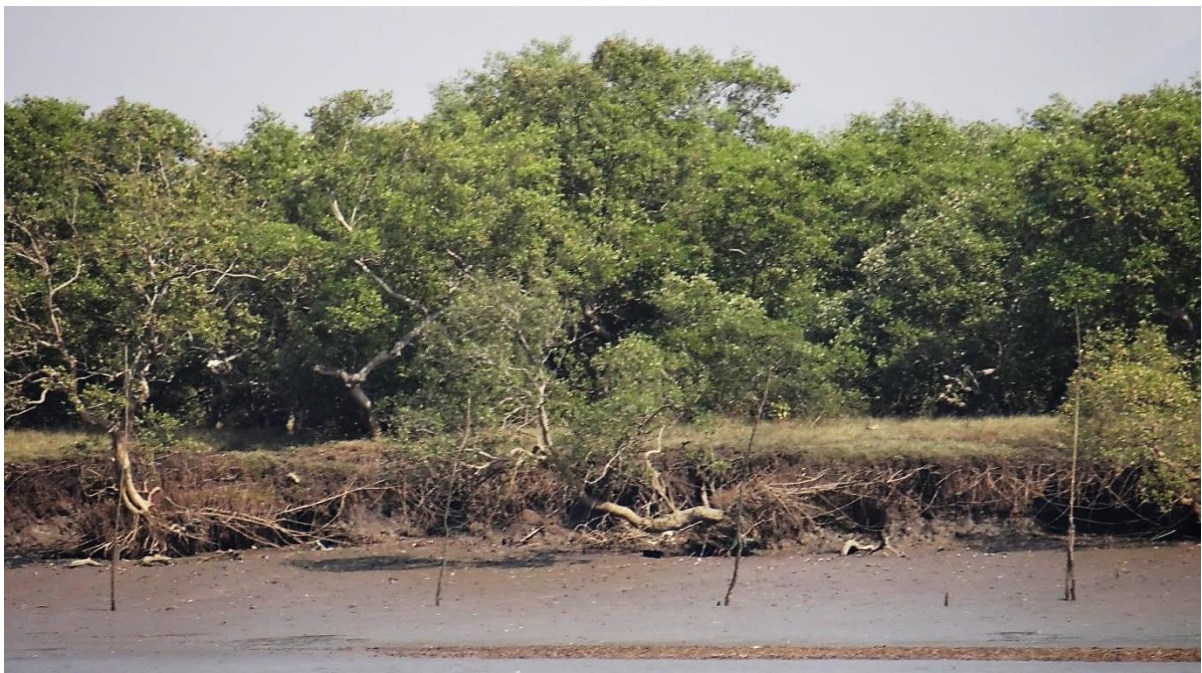
In addition, on either side of the river bank downstream, erosion was observed along with dead and exposed mangroves (Fig. 22). There are several on-going activities such as river bed sand mining at upstream of Dharamtar port(Fig 23) which may alter the hydrology of the river causing the erosion. Detailed field studies and hydrodynamic modelling studies will be carried out for the mangrove management plan.

*Fig. 22: Severe bank erosion leading to death of mangroves in downstream of Amba River*

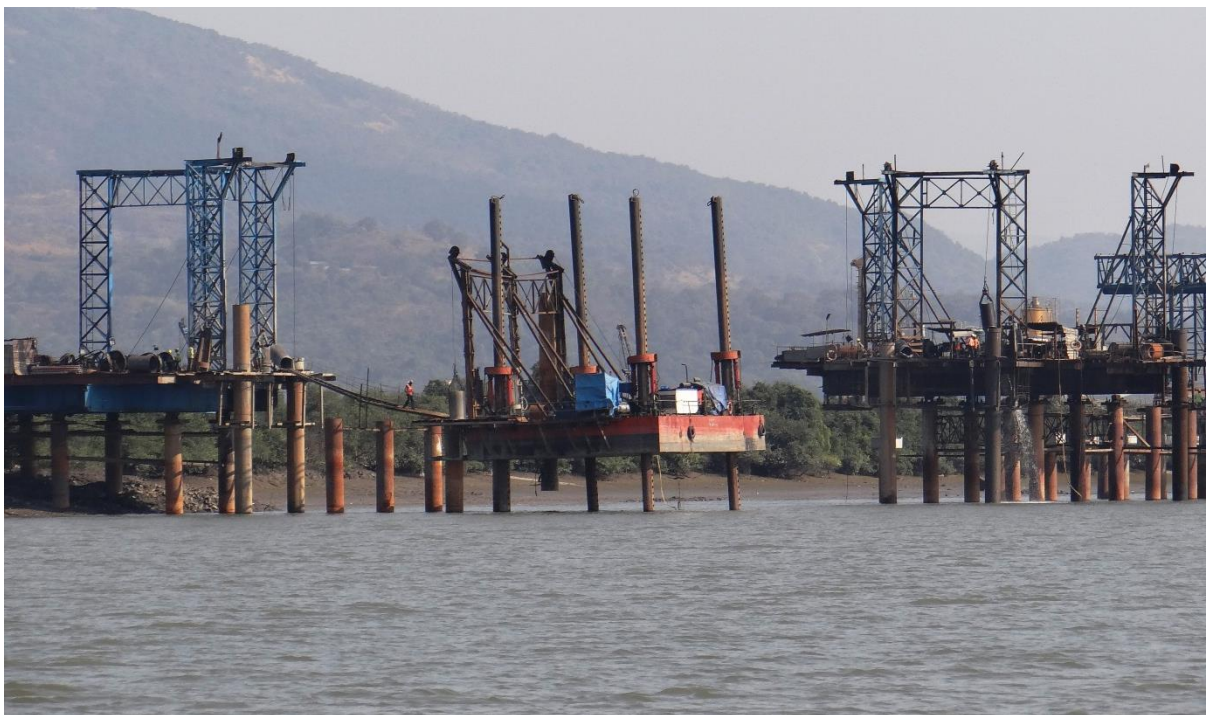
*Fig. 31: On-going construction activities at JSW Dharamtar port. Mangroves are clearly visible behind the construction site.*

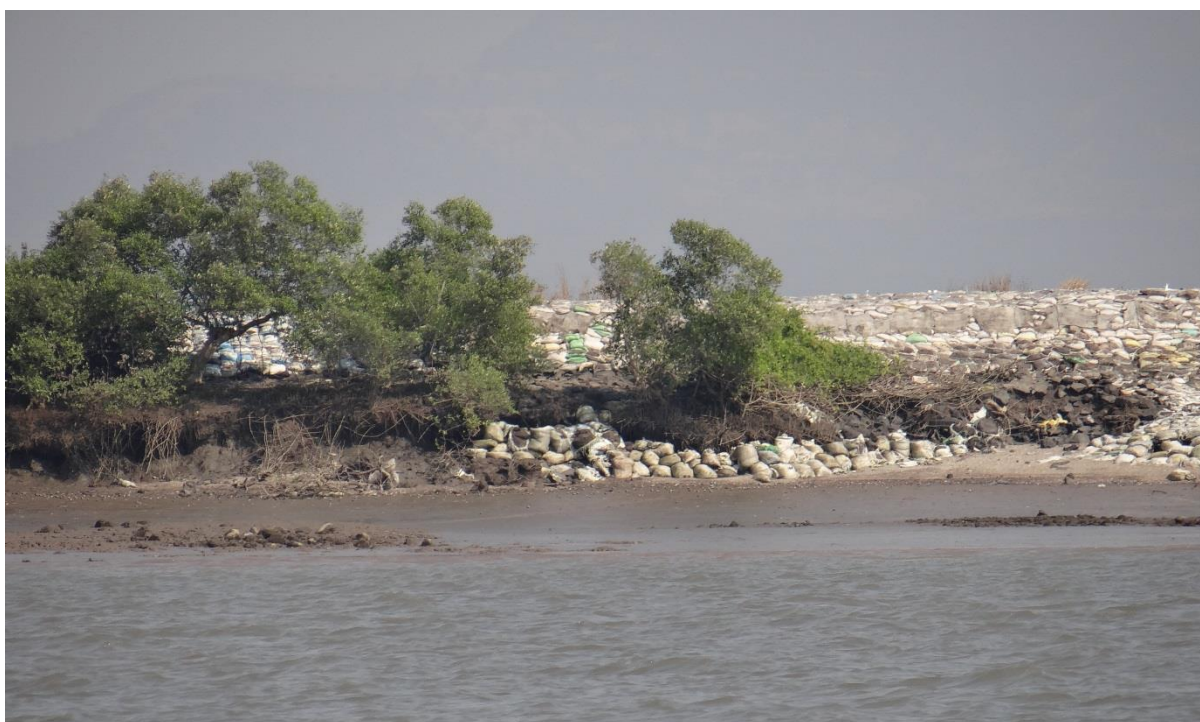
- Coastal erosion was observed near Bhal on the right bank of Amba River (18°46.98'N, 73°0.052'E),
- A total 10 stations covering the upstream, port and downstream regions of Amba River were selected for periodic monitoring (Fig 5).

*Fig. 33: Bank erosion (as observed at 18° 46.98'N, 73°0.052'E), downstream of Amba River*
